Jordan River Watershed Mollusk Surveys: “Last of the Anodonta” 2016 Annual Report

September 19, 2016

To:
Jordan River/Farmington Bay Water Quality Council
Salt Lake City, UT

By
David C. Richards, Ph. D.
OreoHelix Consulting
Vineyard, UT
Phone: 406.580.7816
Email: oreohelix@icloud.com

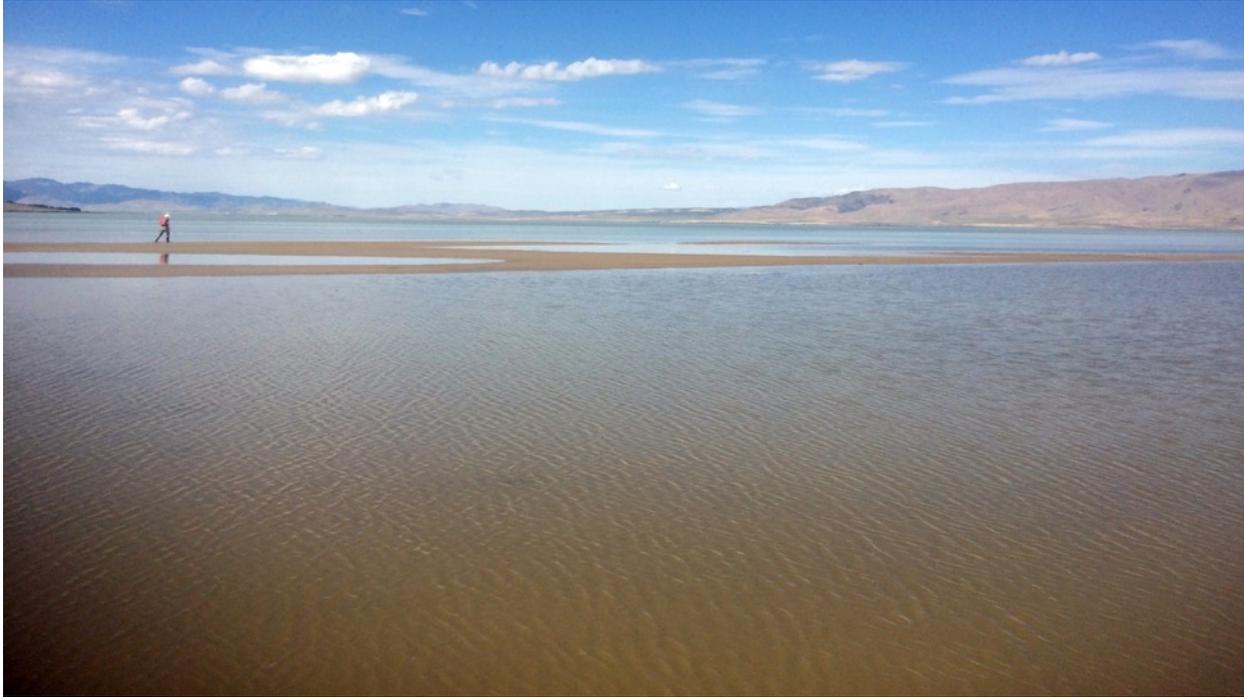
Figure 1. Shoreline and shallow water mollusk survey of Utah Lake at Sandy Beach. View is looking west.

Utah Lake shoreline sampling occurred near Vineyard, UT (Figure 1) on the east side of the lake (Longitude 111°45'57.67" to 111°45'43.80") on several occasions in late August and early September. Approximately 834,000 m² (4.17 km x 200 m) was surveyed by Dr. Richards for live, recently dead, or weathered mollusks and their shells for a total of about twenty hours of surveying. Surveys of this site will continue in 2016 on a sporadic basis.

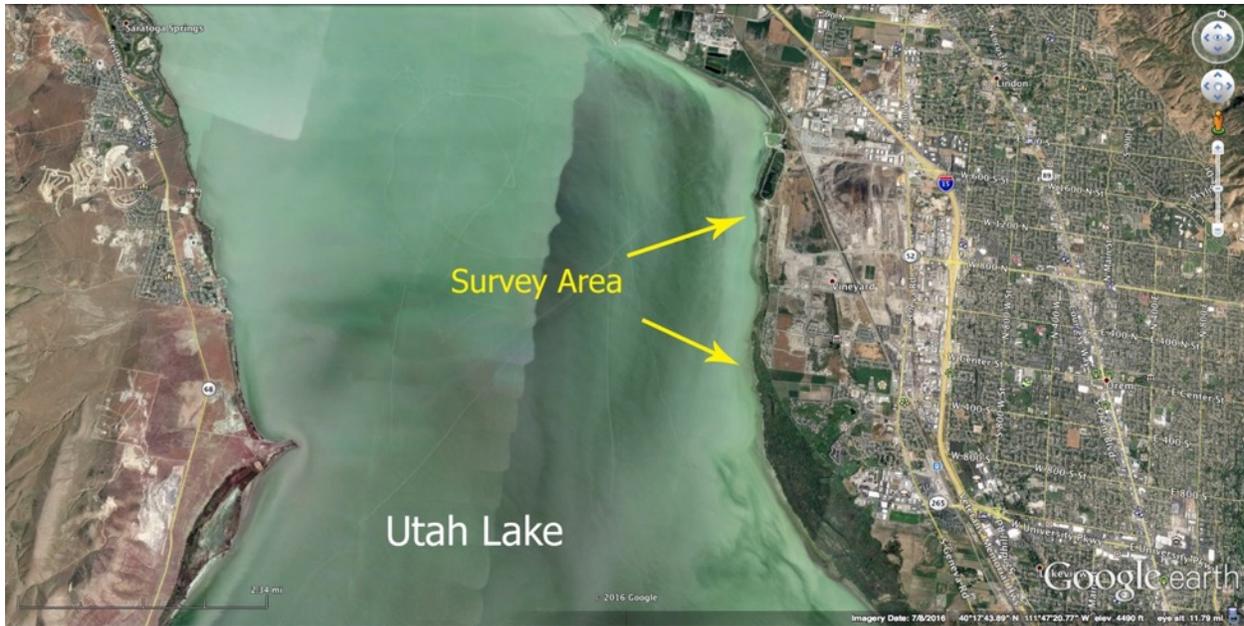
Figure 2. Location of mollusk survey along the shores of Utah Lake, 2016 near Vineyard, UT. Length of shoreline was approximately 4.2 km where many freshwater springs occurred. This type of spring influenced habitat is likely one of the best types for finding any remnant native mussel populations.

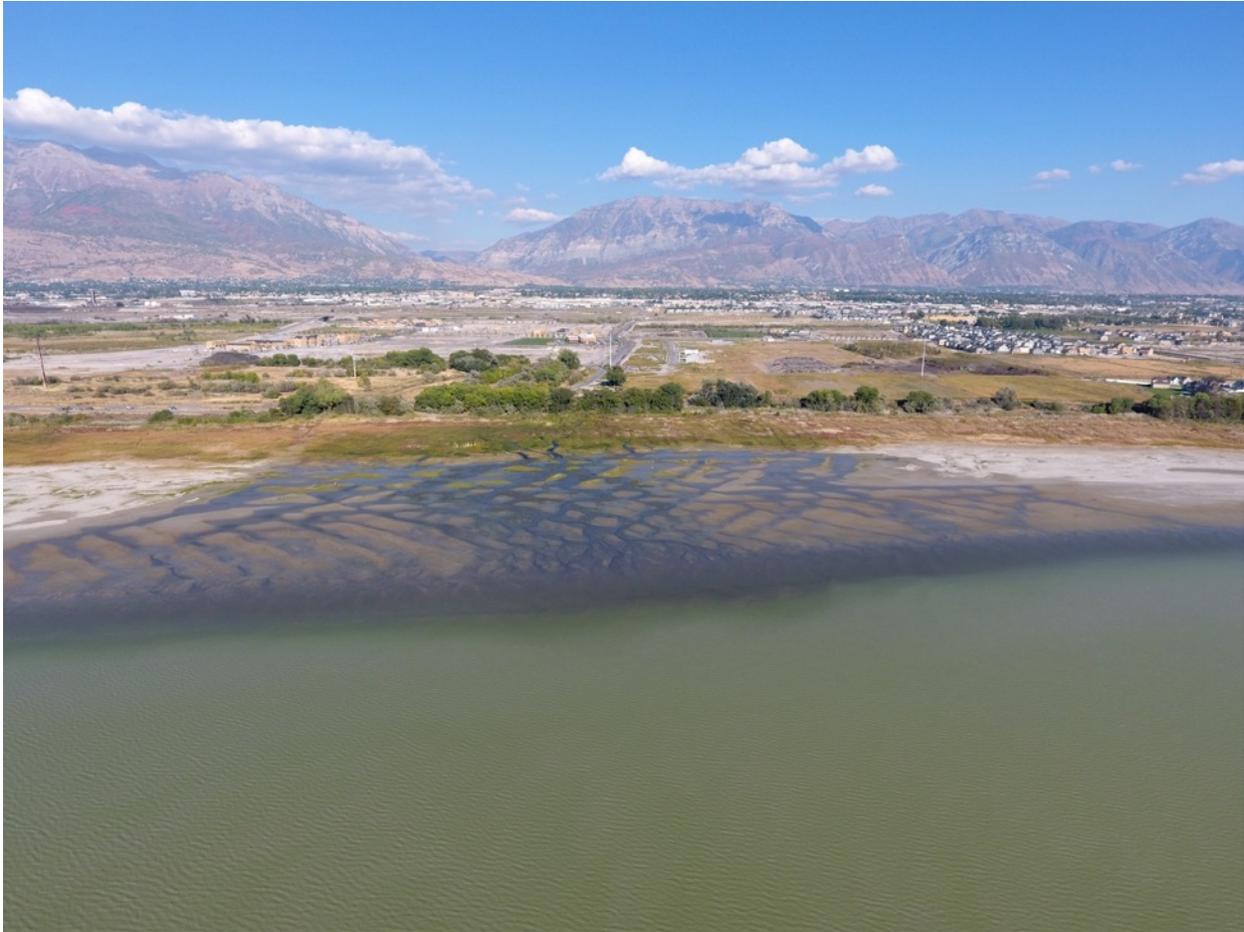
Figure 3. Aerial view of northern springs of the Vineyard spring complex, between Lindon Marina and Powell Slough, Utah Lake. September 2016. These springs may have historically been a creek/river but are now inundated and covered by Geneva Steel Co. lands and recent subdivisions and presently only surface flow occurs at this location for a short distance before entering Utah Lake. Utah Lake is the green body of water in the foreground. Numerous subdivision developments are occurring up to the normal meander line of the lake.

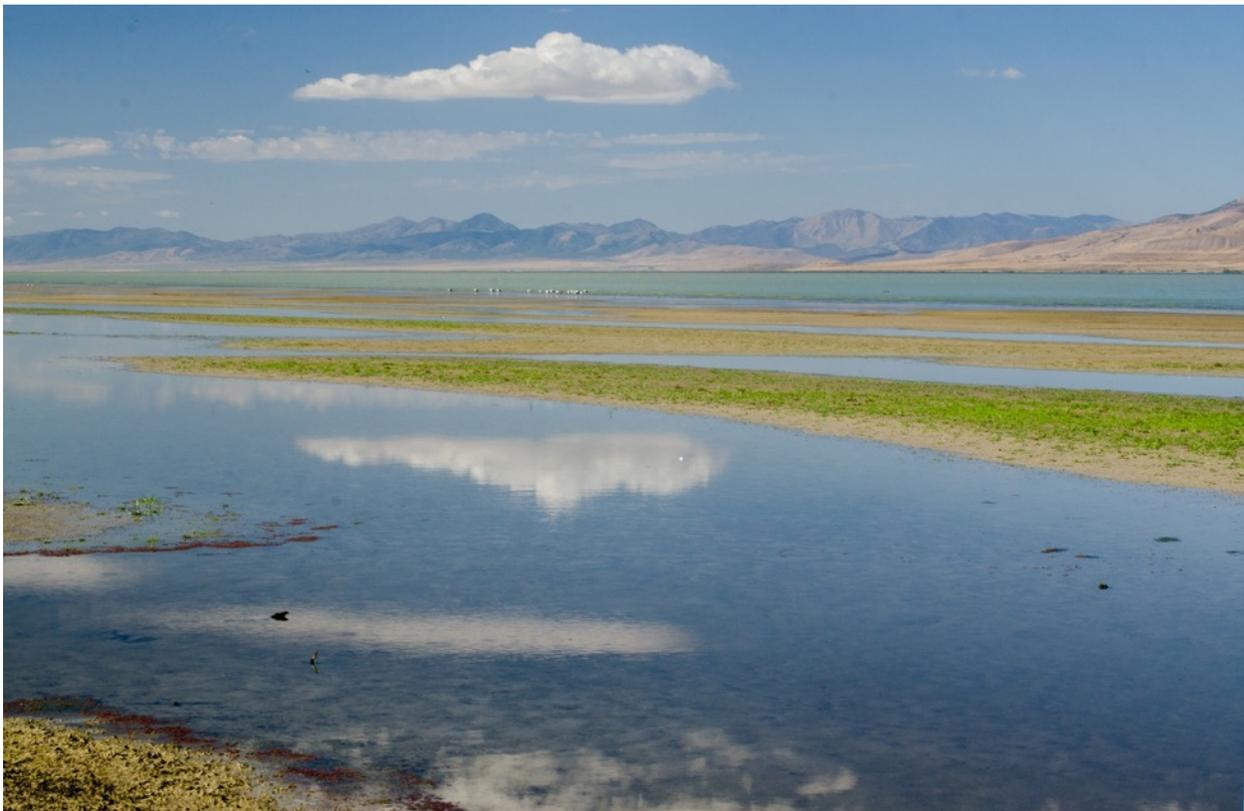
Figure 5. View of Utah Lake near Vineyard, UT looking SW. The lake is in the far distance with several pelicans observable on its shoreline. Water in foreground out to the Utah Lake shoreline is pools from the many springs in the area.

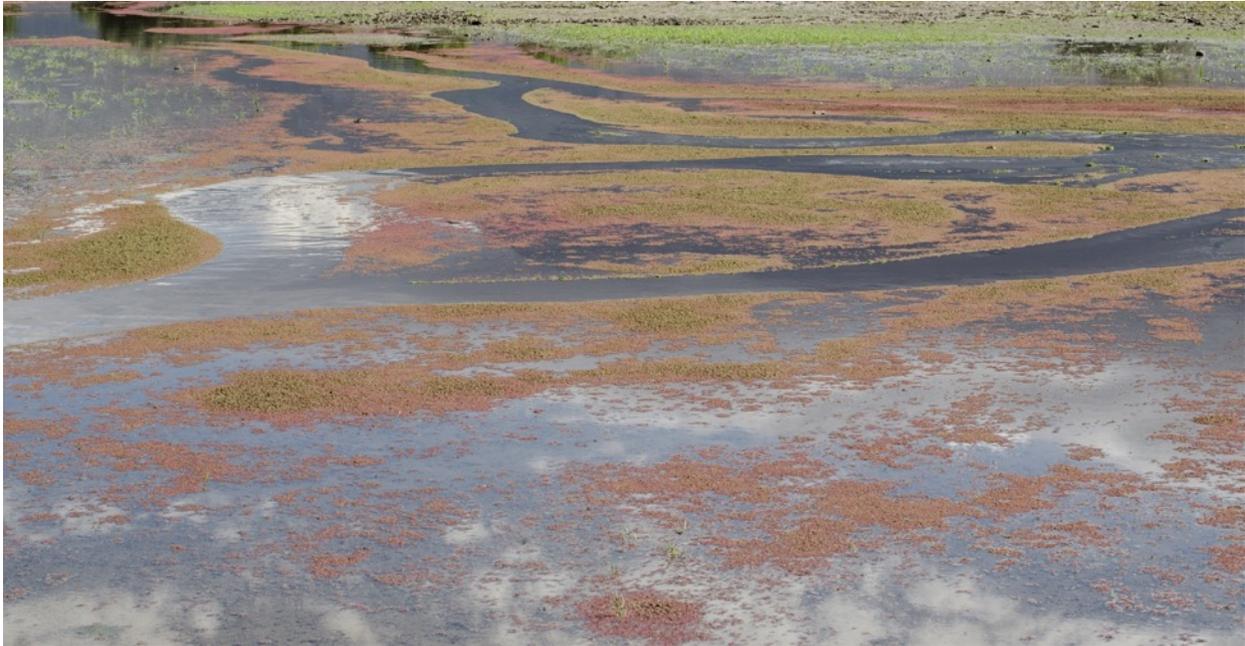
Figure 6. Flowing spring water and algae and aquatic vegetation at the most northerly spring in the survey near Vineyard, UT, September 5, 2016.

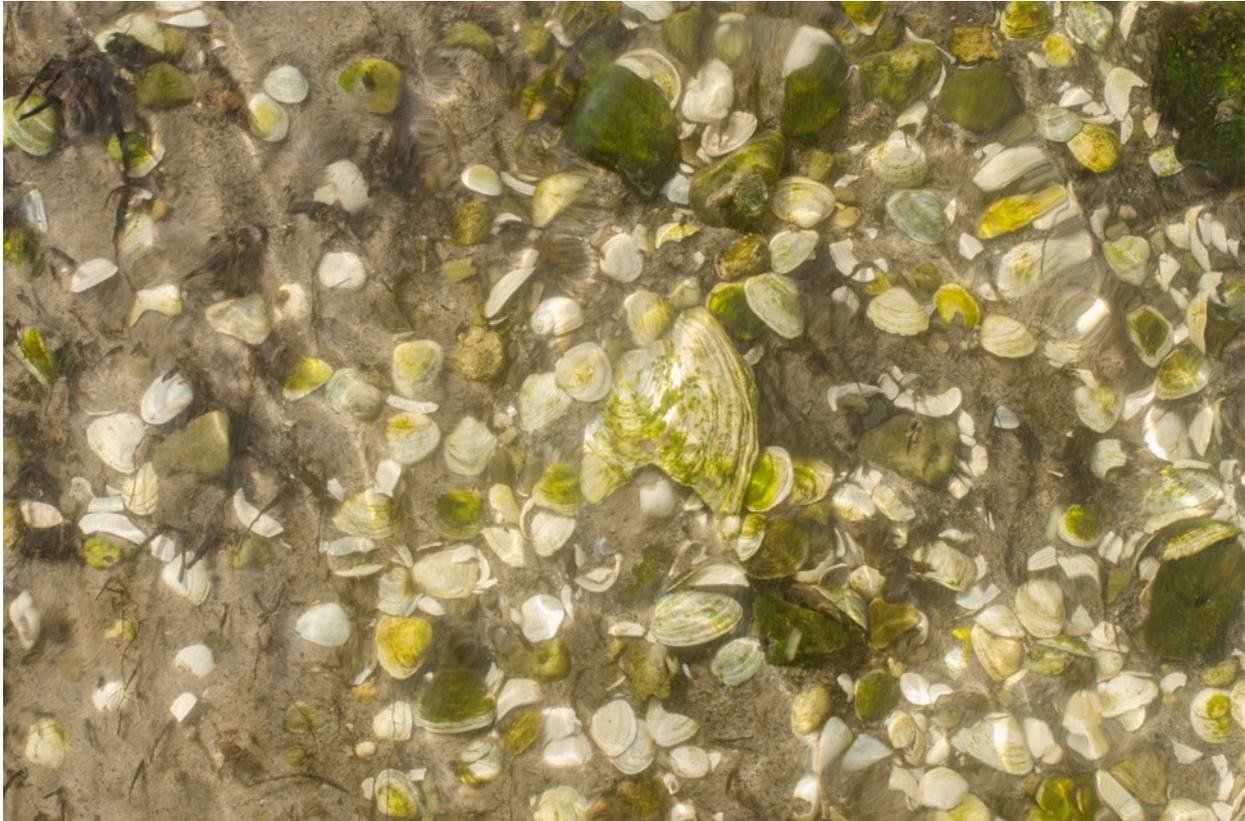
Figure 8. Weathered mollusk shells and fragments in the main channel of the most northerly spring surveyed. Shells are mostly fingernail clams (Family Sphaeriidae) with one large Anodonta sp. fragment visible in the center of the photo.

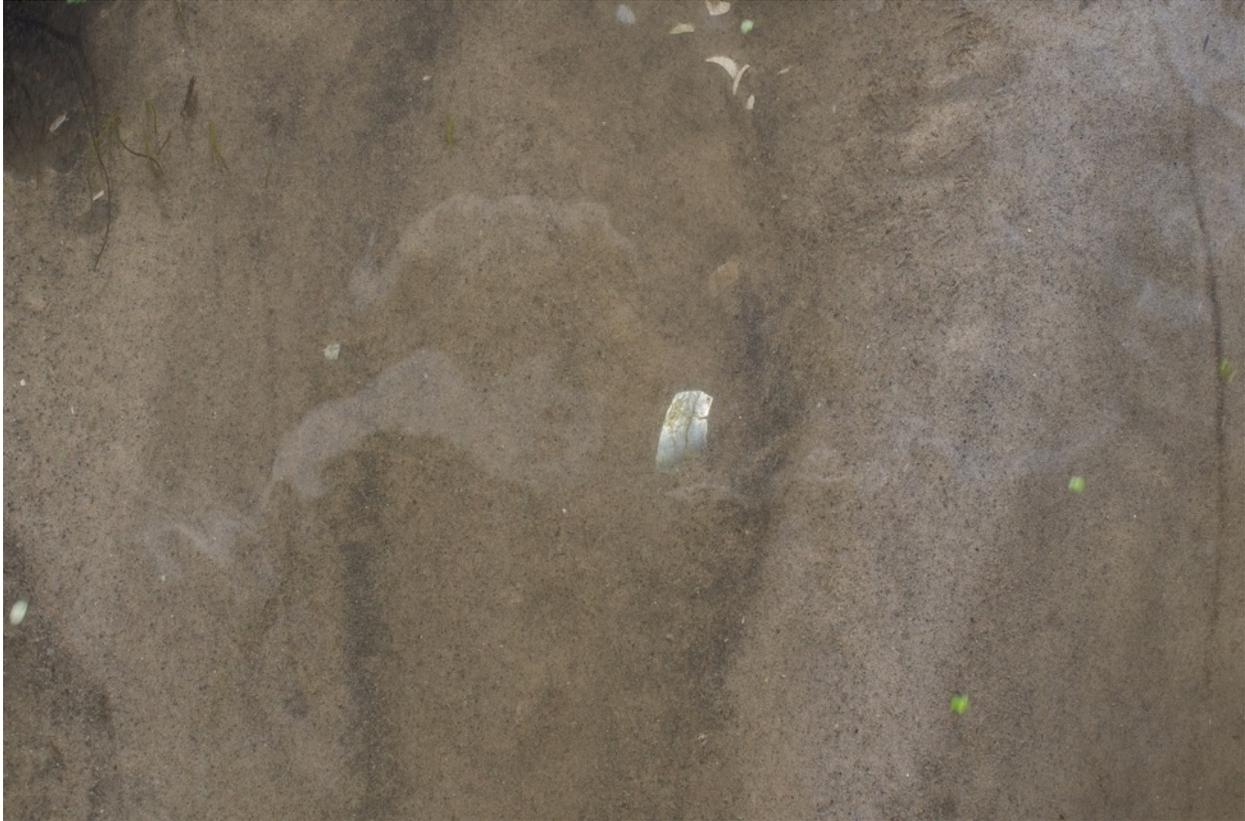
Figure 9. A highly weathered Anodonta shell fragment found in the most northerly spring.

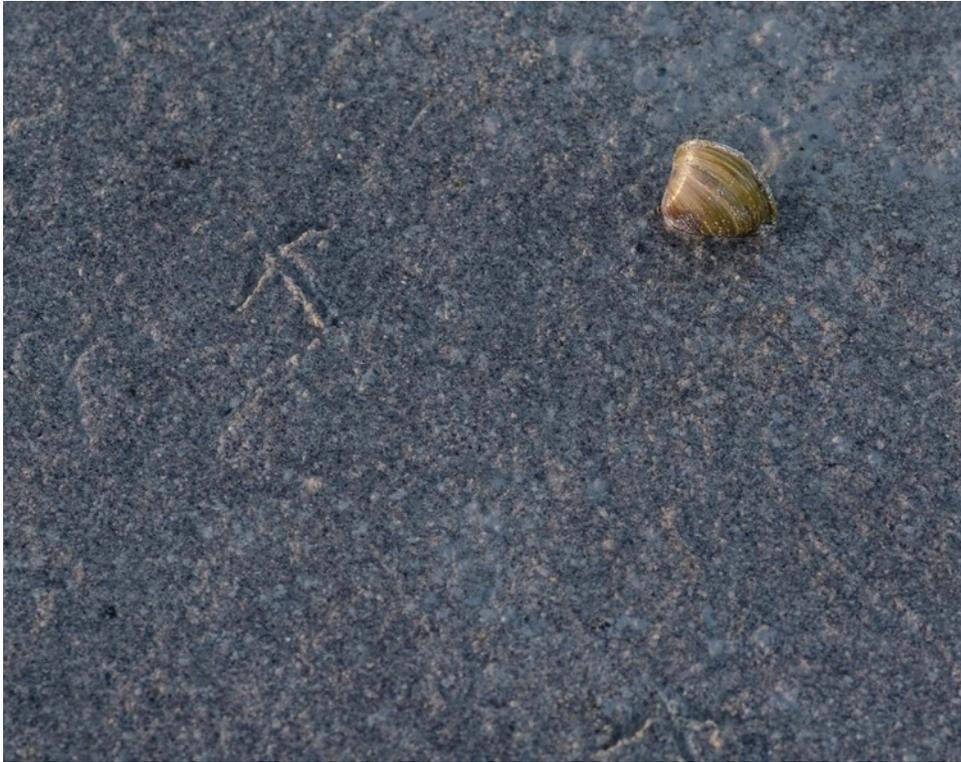
Figure 10. A live Corbicula exposed due to receding Utah Lake waters. Tracks of potential bird predators are also visible.

There were many ($N > 1000$) widely scattered Corbicula popping out of the sediments near spring influenced substrate. Some Corbicula were still alive, while most were recently killed by predators. Shorebirds and raccoons pulled many of the Corbicula out of substrate, waited until the clams became dehydrated and exhausted and then were eaten. Even though there were thousands of Corbicula, they were more dispersed and at lower densities than anticipated. Corbicula tends to occur in habitats and conditions where Anodonta likely occurred in the past (Richards 2015 and personal observations). It is probable that Anodonta biomass (densities) was at least as much as what now occurs with Corbicula in Utah Lake and in the entire Jordan River drainage.

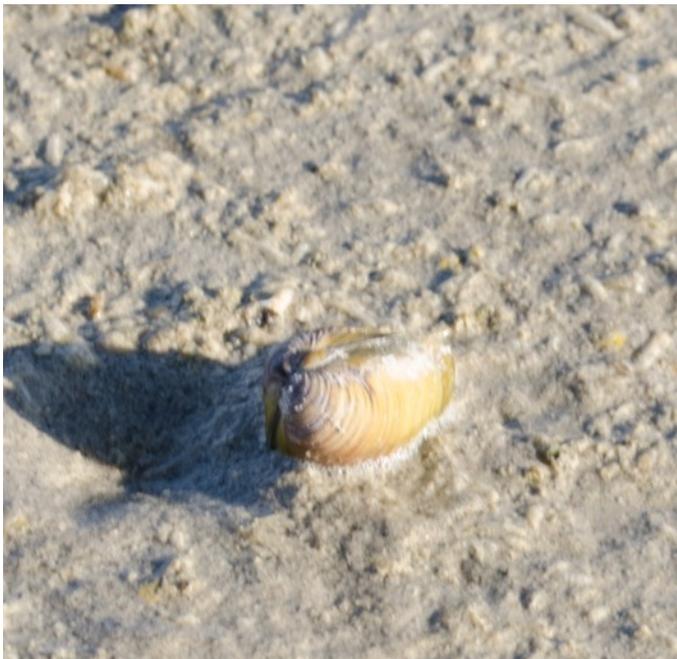
Figure 11. Another Corbicula exposed to predators during receding Utah Lake shoreline, September 2016.

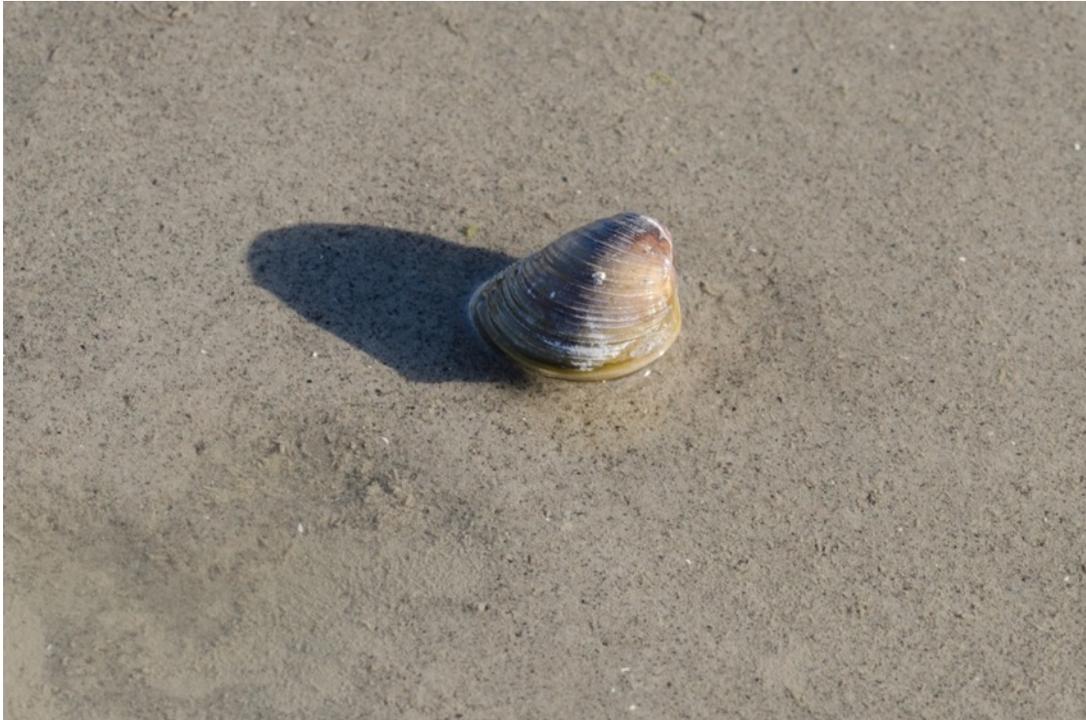
Figure 12. Corbicula debating whether to leave receding Utah Lake waters and imminent desiccation or becoming exposed to predators near Vineyard, UT.

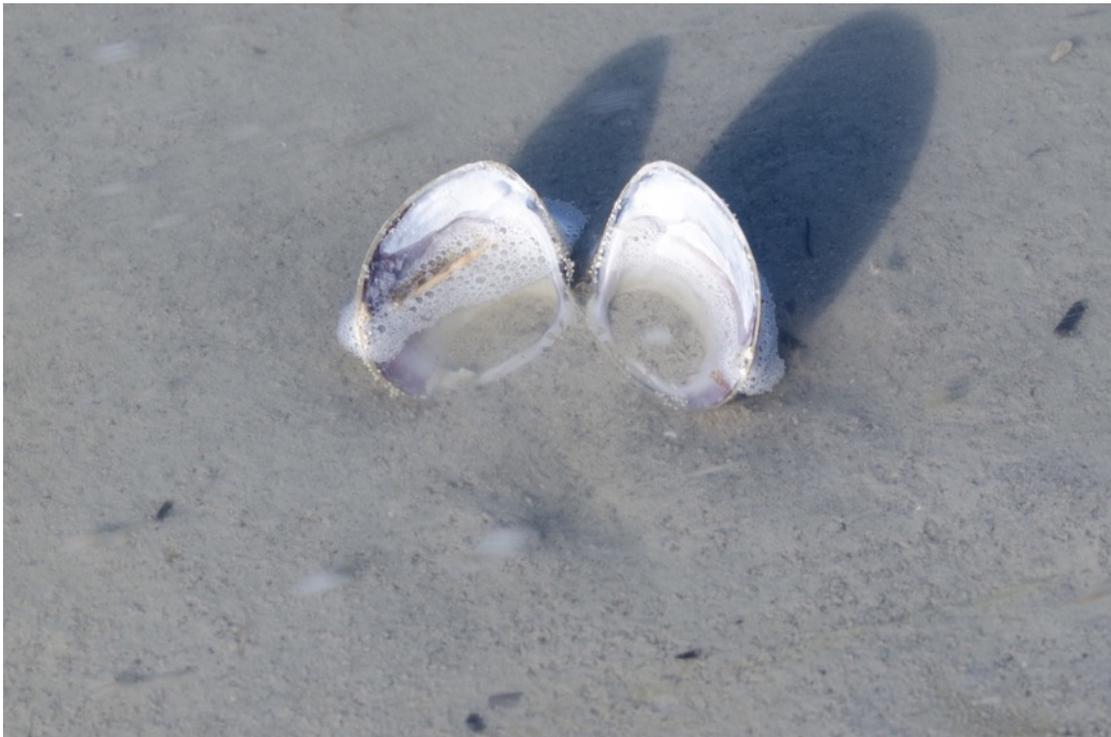
Figure 13. Corbicula that made the wrong choice and was eaten by predators, Vineyard, UT, September 2016.

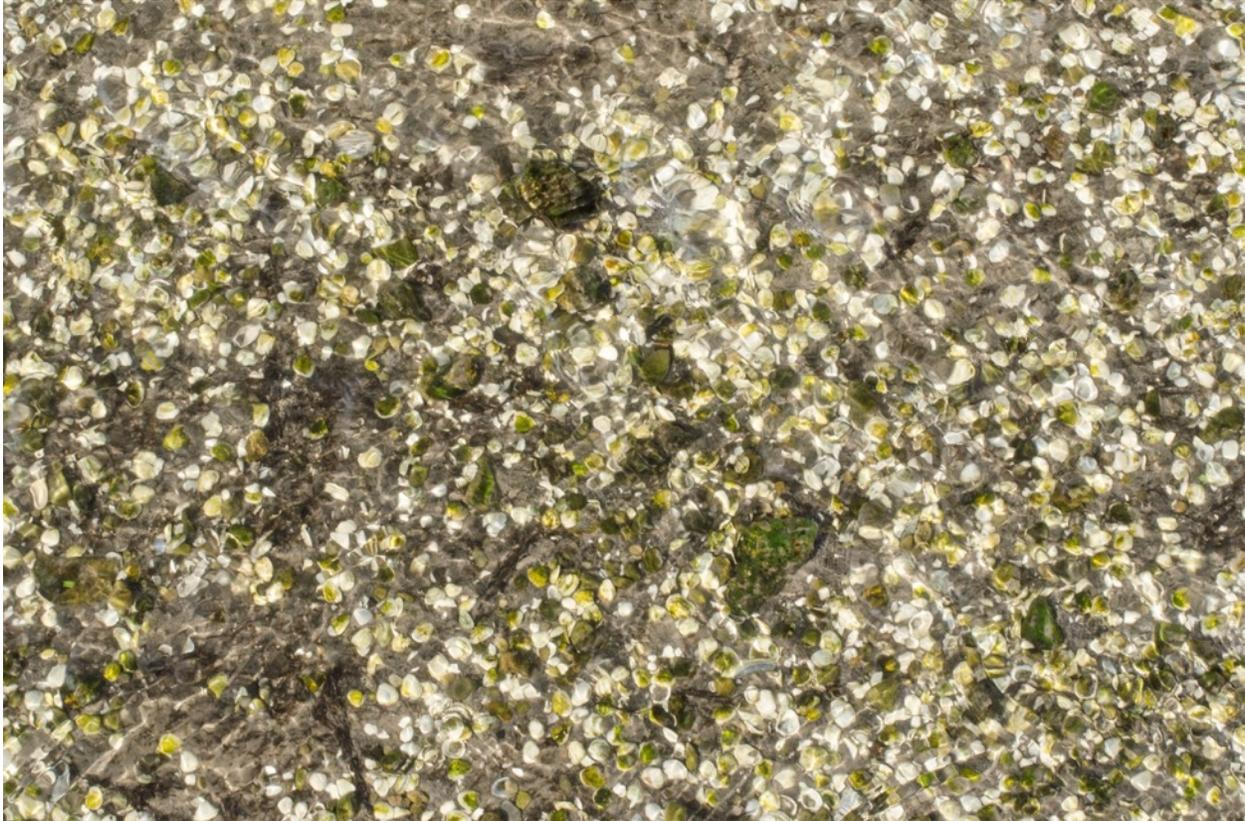
Figure 14. Weathered mollusk shells, primarily native fingernail clams (Family Sphaeriidae) in one of the spring tributaries to Utah Lake near Vineyard, UT. This is typical of the number and densities of shells found covering the substrates in these spring tributaries.

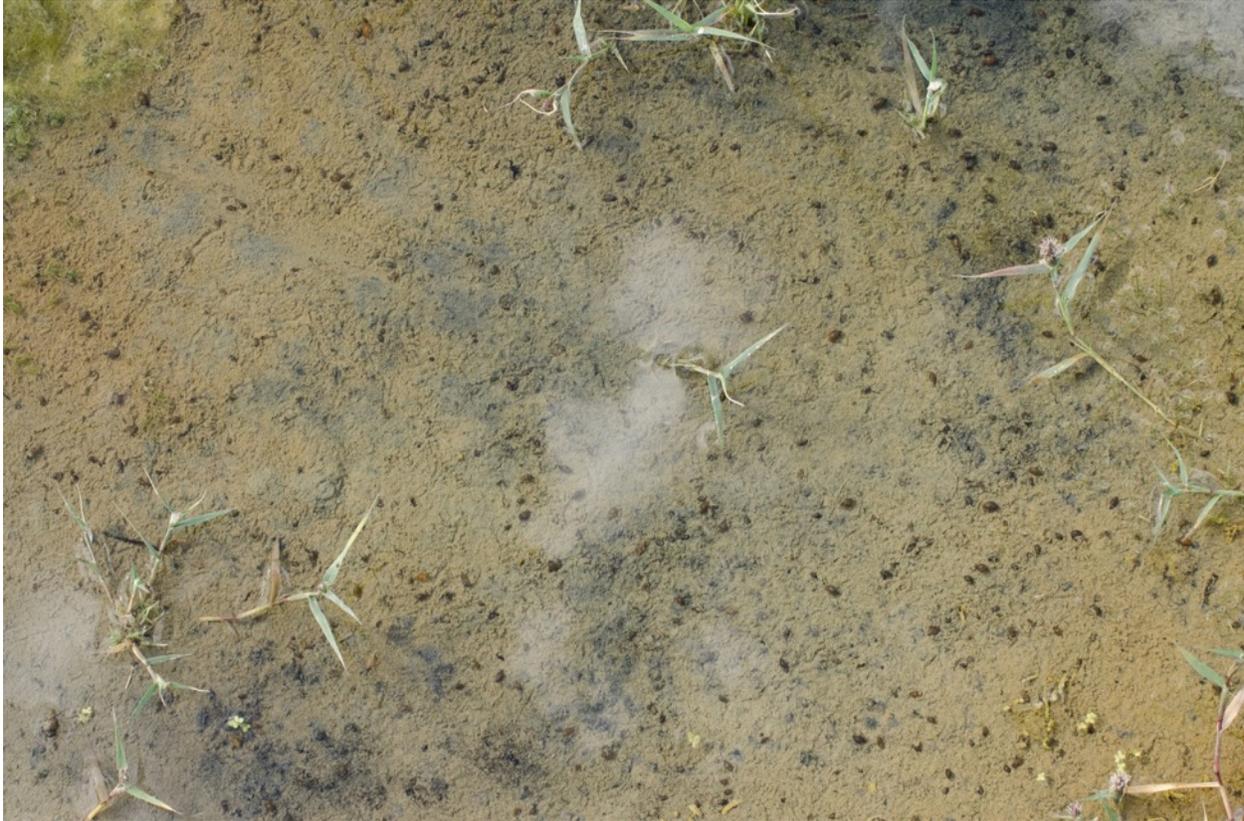
The only live mollusks other than *Corbicula* that were found in the survey were *Physa* snails which were abundant in many of the spring pools (Figure 15).

Figure 15. The only living gastropods found in the springs were physa snails. Snails are all of the dark spots in the photo.

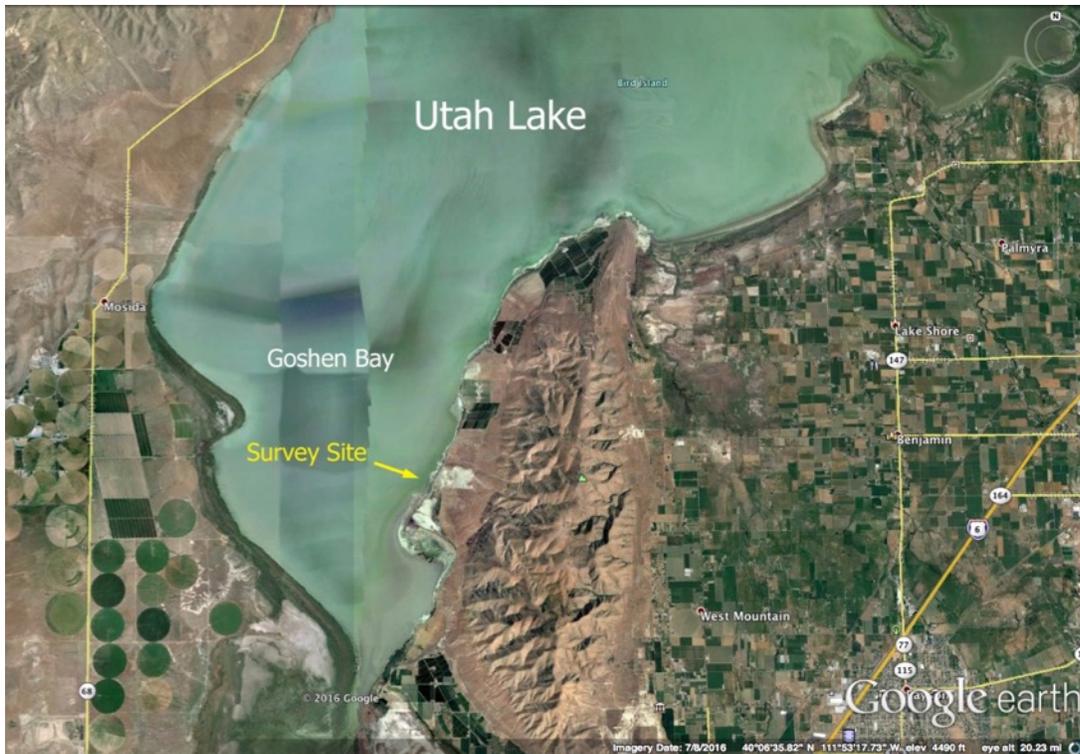
No live or recently dead native mussels were encountered. A few highly weathered *Anodonta* fragments were found. There were wave washed piles of weathered pulmonates and prosobranch snail shells as well as fingernail clams. Several live *Corbicula* were also found. Again, the wave washed piles of highly weathered shells is typical of Utah Lake's shoreline indicating a once thriving native mollusk assemblage unique to the western USA.

Figure 16. Goshen Bay survey site.

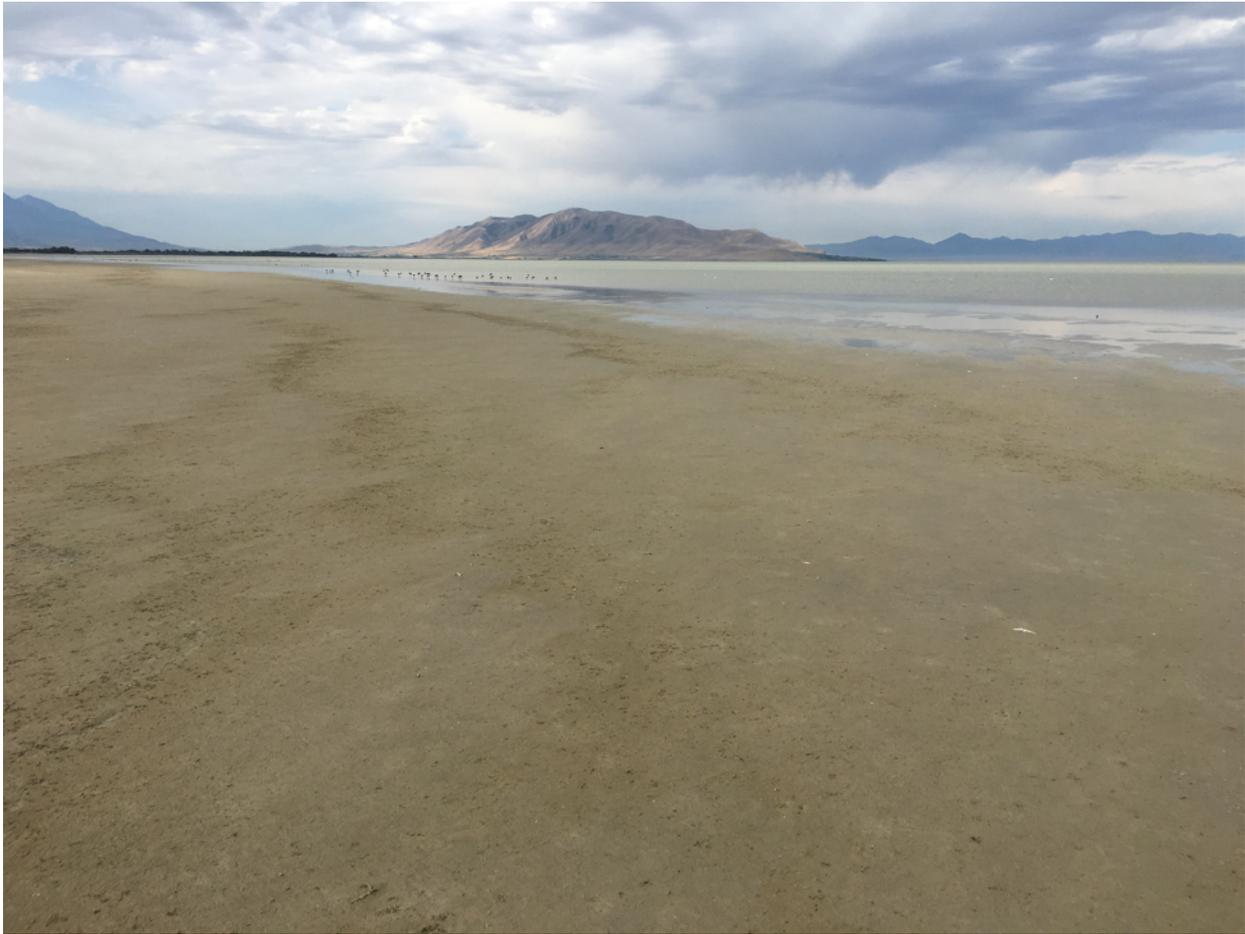
Figure 18. Shoreline of Utah Lake near SW corner of Provo City Airport looking south on August 17, 2016. Receding Utah Lake waters although indicative of the severe drought conditions the area is experiencing, were ideal for surveying exposed mollusks.

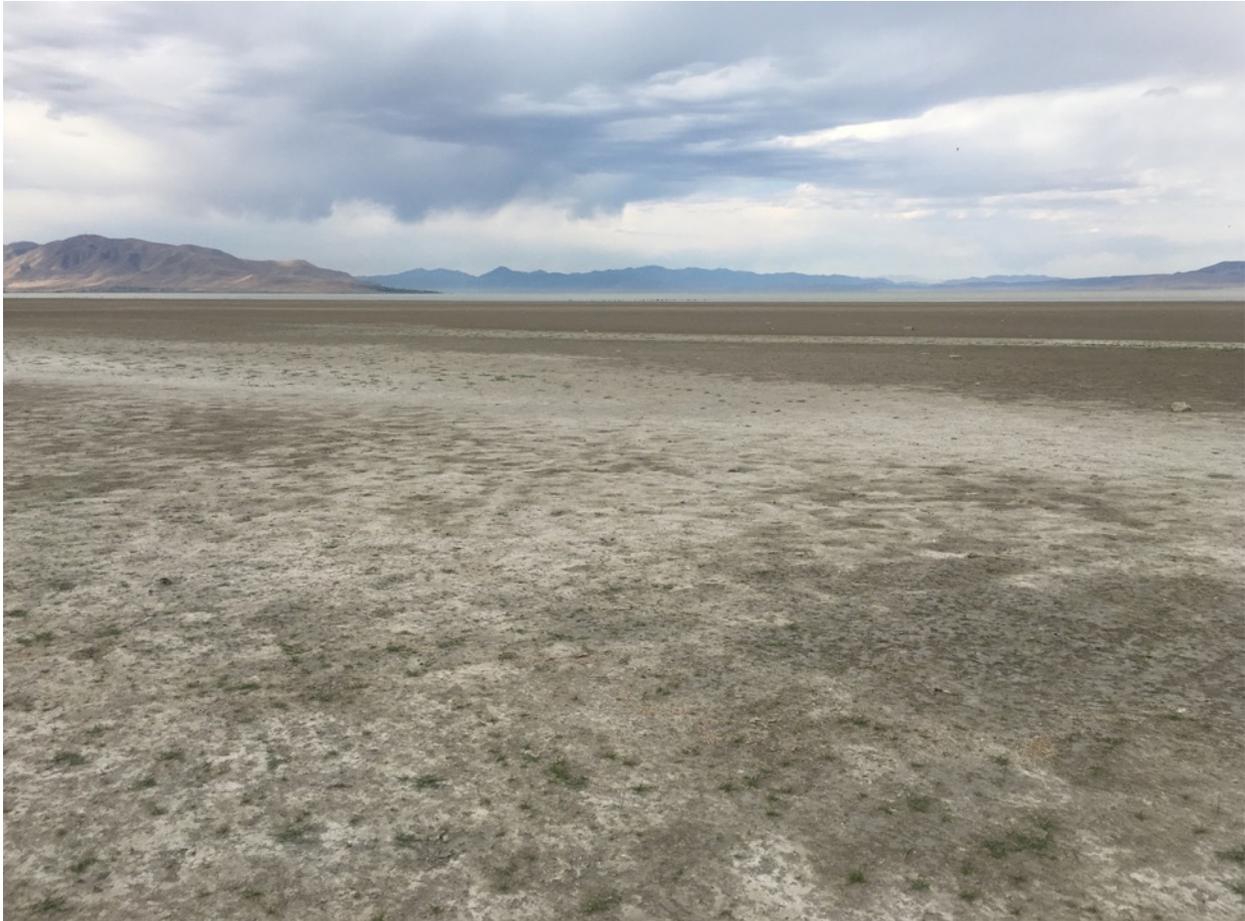
Figure 19. Shoreline of Utah Lake near SW corner of Provo City Airport looking southwest on August 17, 2016. Area in foreground is where weathered mollusk shells started to become more abundant and increased in abundance up to the lakes meander line (see next photo).

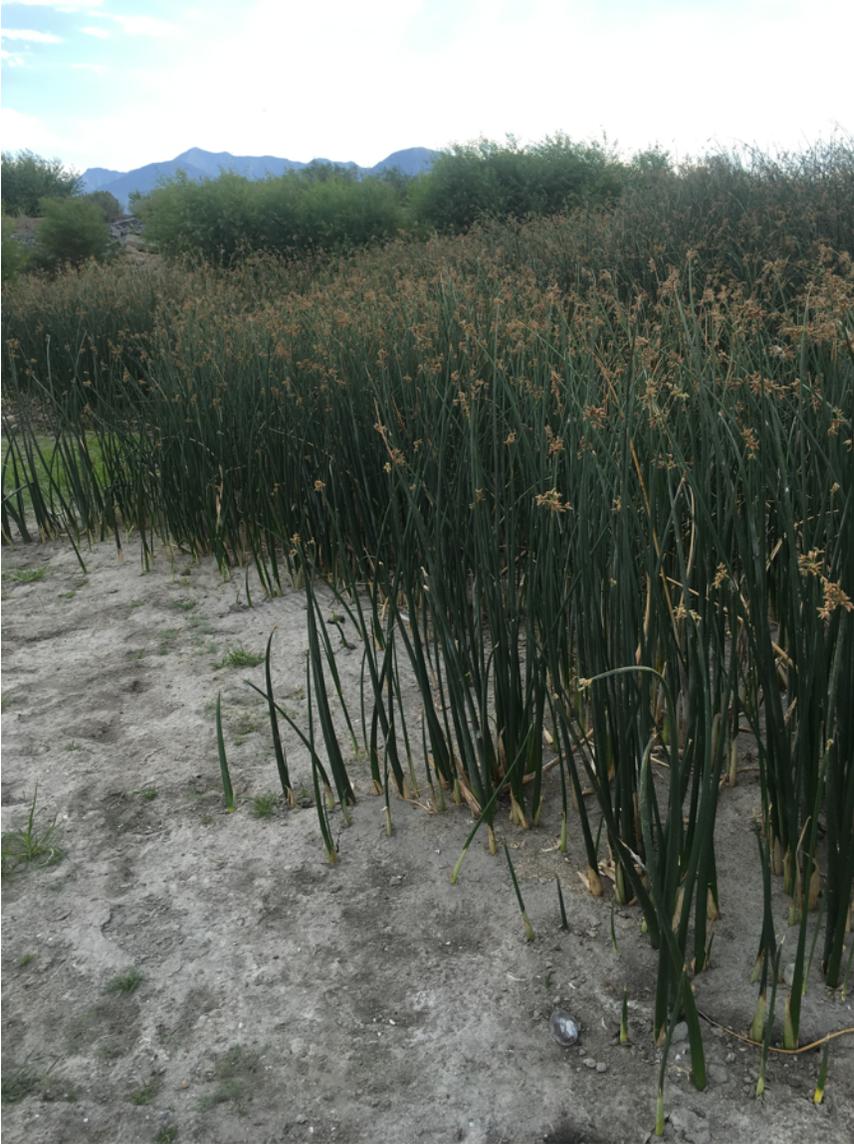
Figure 20. Area near normal meander line of Utah Lake shoreline near SW corner of Provo City Airport. Note weathered *Anodonta* shell in foreground right, near bulrush. Thousands of weathered shells including *Anodonta* and an occasional *Utah valvata* can be found all along this area for several kilometers. Utah Lake was a unique molluskan hotspot in the western U.S. in the not too distant past.

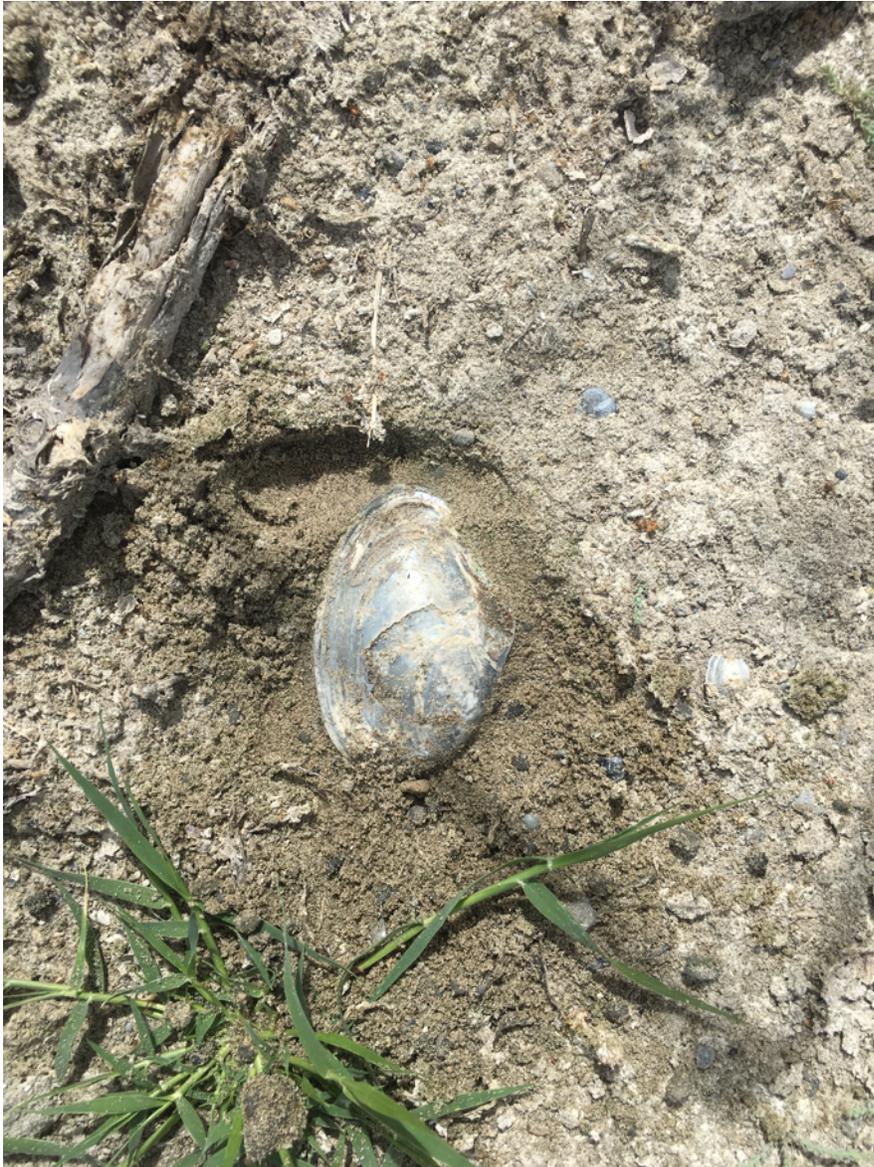
Figure 21. Weathered Anodonta shell at normal meander line of Utah Lake near SW corner of Provo Airport, July 29, 2016.

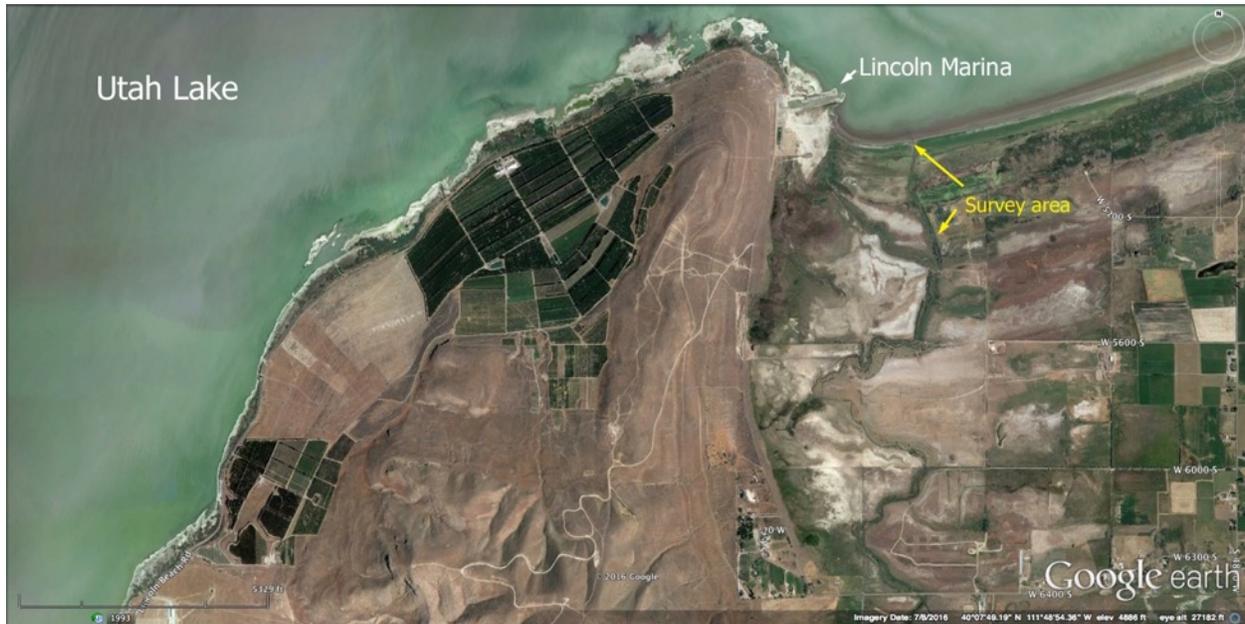
Figure 22. Mollusk survey location on Beer Creek at confluence with Utah Lake. Survey was conducted on August 15, 2016.

No live or recently dead native mussels were encountered. This was expected because this section of Beer Creek is often without water. Native mussels need water. Three highly weathered *Anodonta* shell fragments were found, further demonstrating that Beer Creek was once suitable habitat for *Anodonta*.

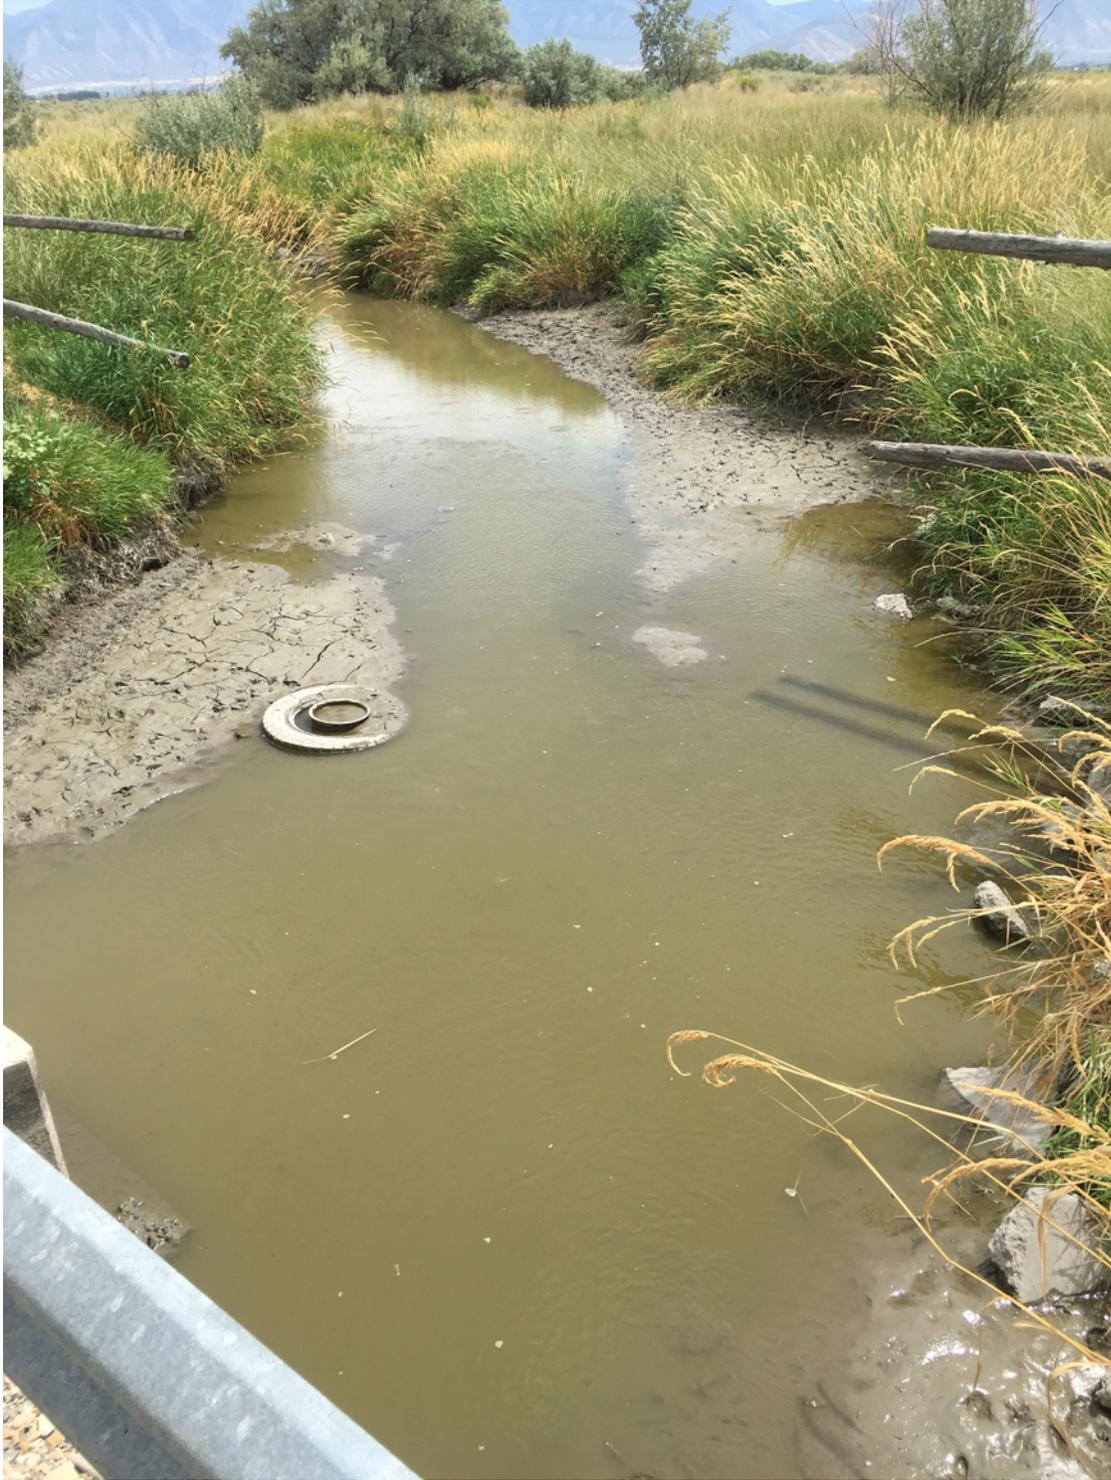
Figure 23. Stagnant pool of Beer Creek water at Lincoln Beach Road bridge looking north, August 15, 2016

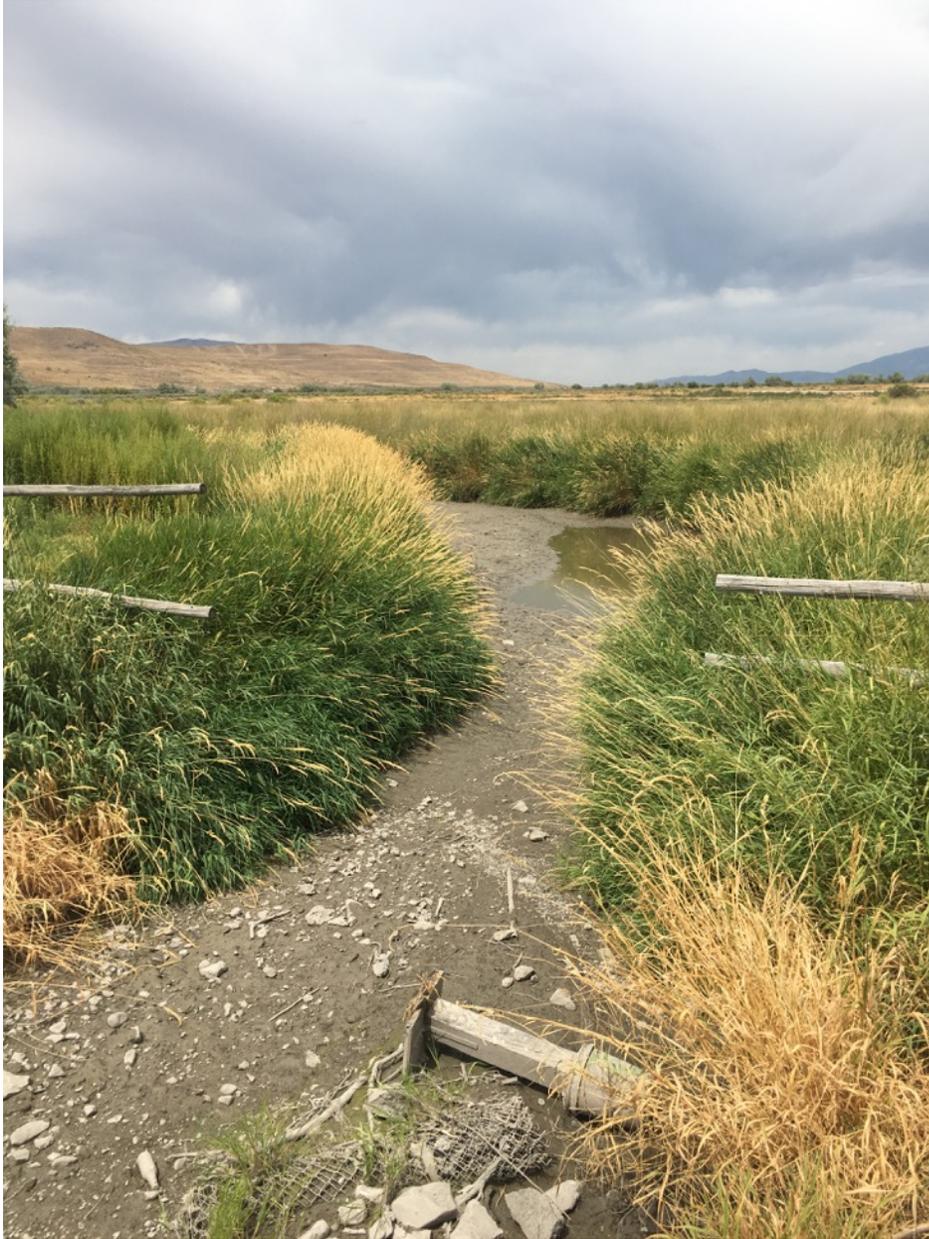
Figure 24. Stagnant pool of Beer Creek water at Lincoln Beach Road bridge looking north, August 24, 2016. This is the same location as the previous photo.

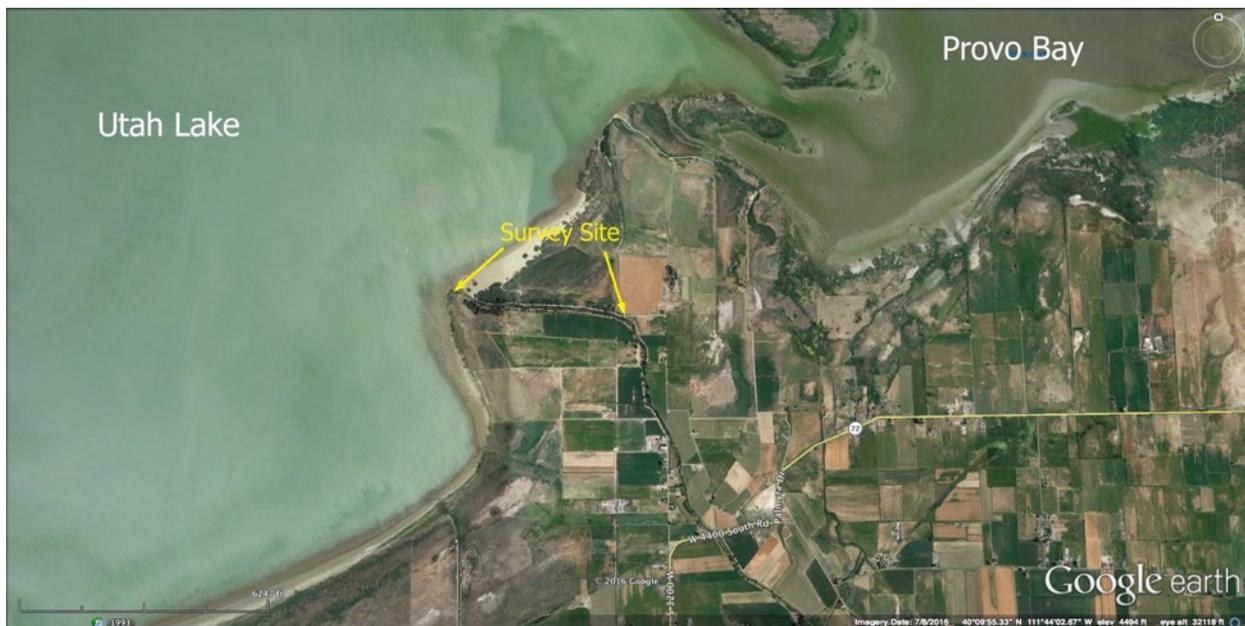
Figure 25. Mollusk survey site on Spanish Fork River at confluence with Utah Lake.

No live or recently dead mussels were encountered, although as was the case for most survey locations, several highly weathered *Anodonta* fragments were found indicating that the Spanish Fork River was also once prime habitat for native mussels.
