Jordan River Watershed Mollusk Surveys: “Last of the Anodonta” 2016 Annual Report

September 19, 2016

To:
Jordan River/Farmington Bay Water Quality Council
Salt Lake City, UT

By
David C. Richards, Ph. D.
OreoHelix Consulting
Vineyard, UT
Phone: 406.580.7816
Email: oreohelix@icloud.com

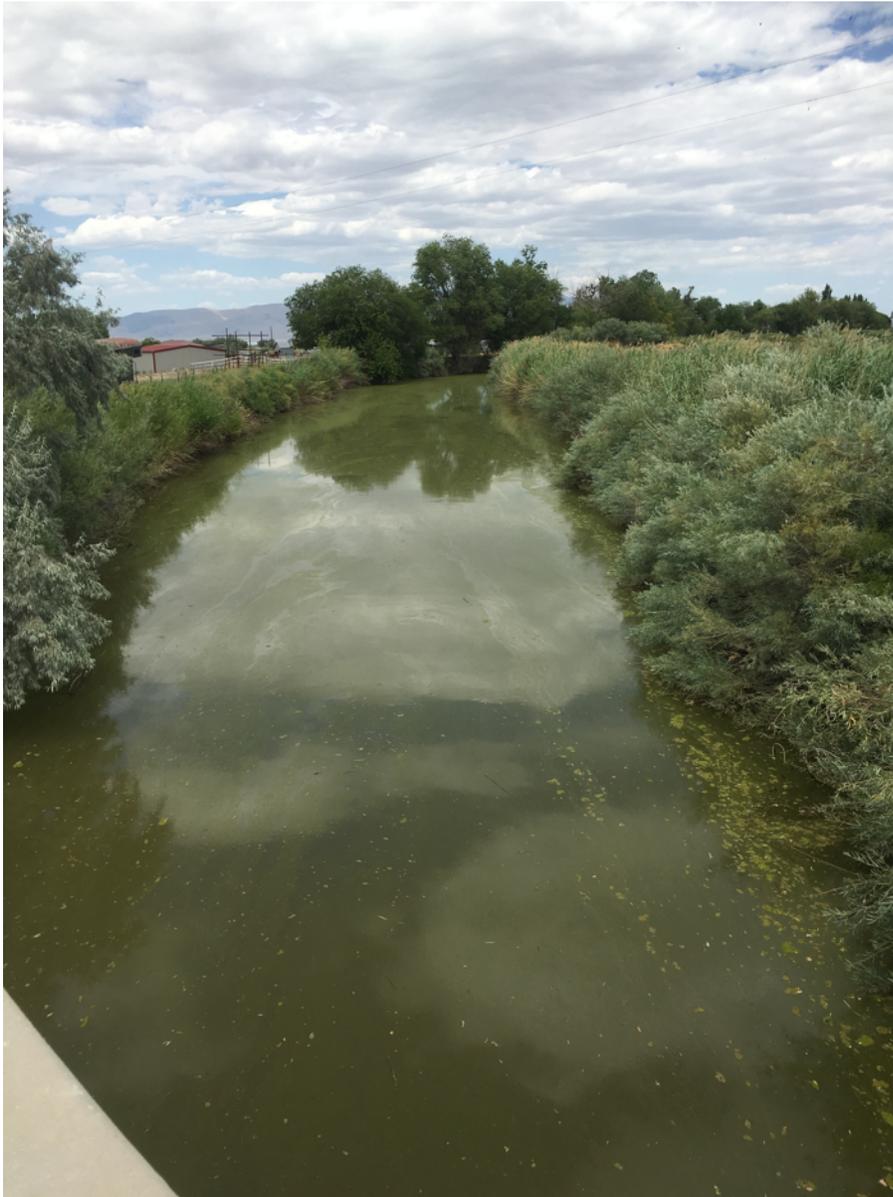
Figure 26. Spanish Fork River and algal bloom just upstream of a diversion dam and downstream of W 4000 S bridge on July 18, 2016. Flow was estimated to be $\ll 1$ cfs.

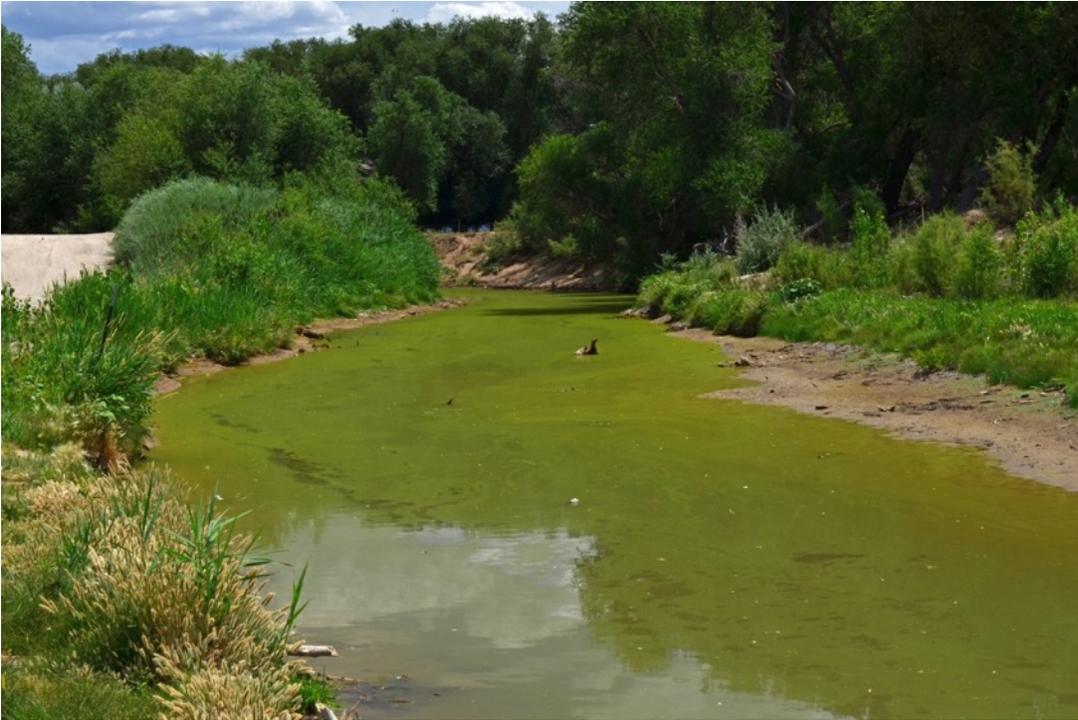
Figure 27. Green algal bloom on Spanish Fork River as it enters Utah Lake on July 18, 2016. Flows were estimated to be < 5 cfs and most of the water was pooling and stagnating before entering the lake.

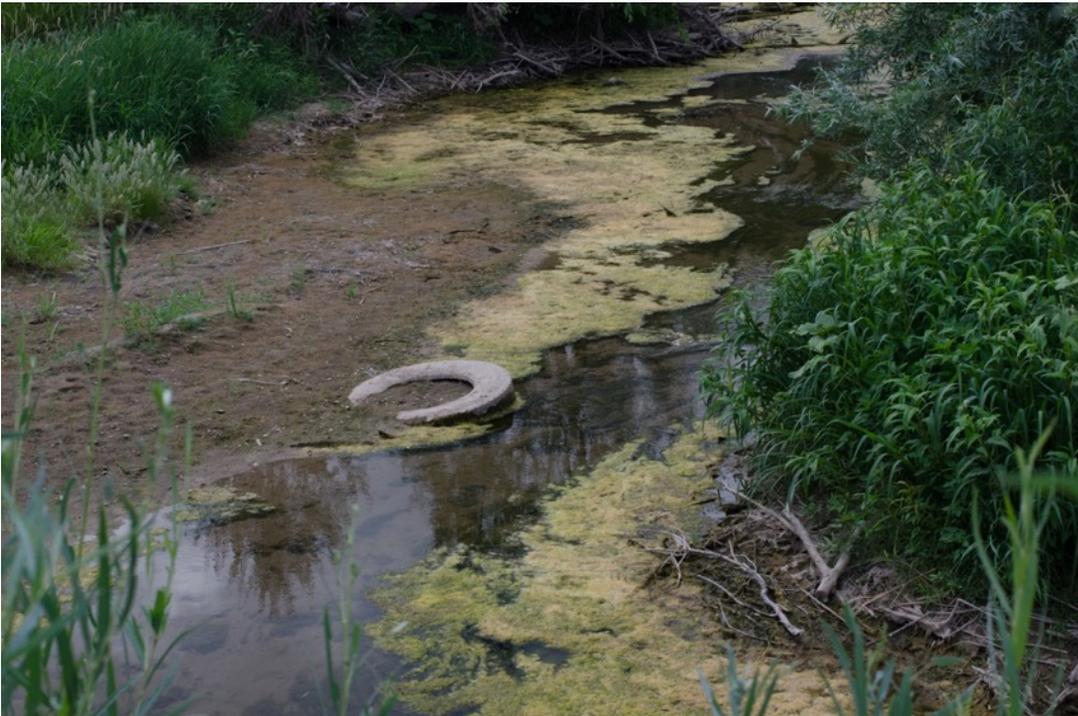
Figure 28. Spanish Fork River between W 4000 S bridge and confluence with Utah Lake on July 18, 2016. Most of the river was diverted for irrigation and flows here were estimated at <3 cfs. Notice thick algal mats indicating nutrient overload.

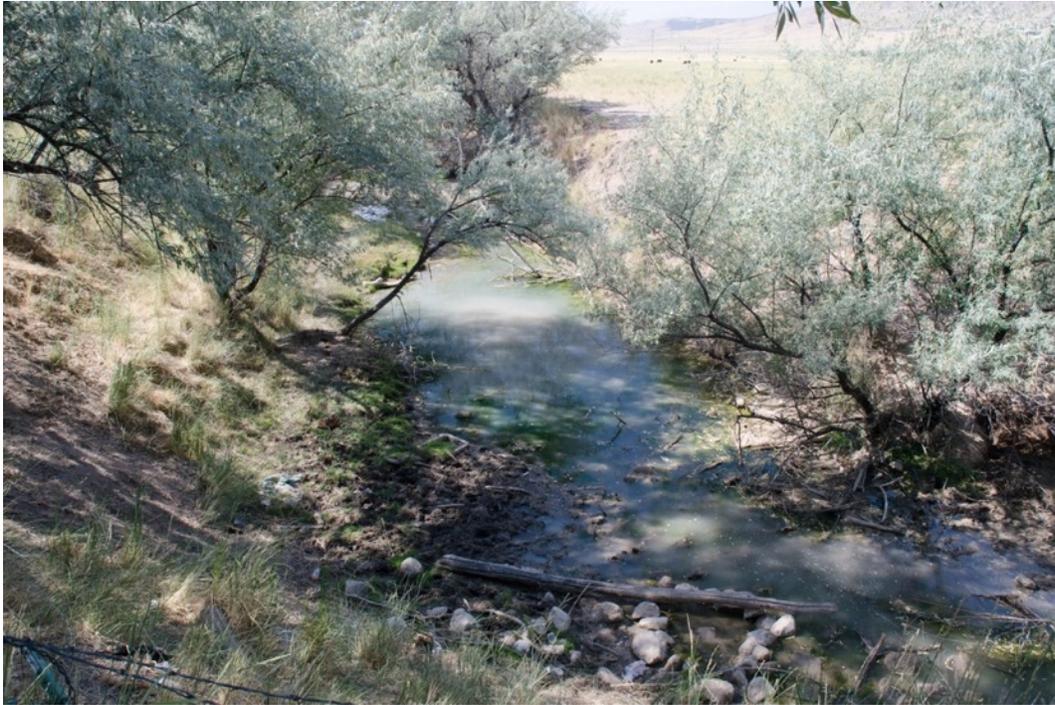
Figure 29. Stagnant pool in Currant Creek looking upstream from outlet of Burraston Ponds, August 2016. Low flows, increased exposed substrates, algal blooms, stagnant conditions, and Corbicula dominate the creek.

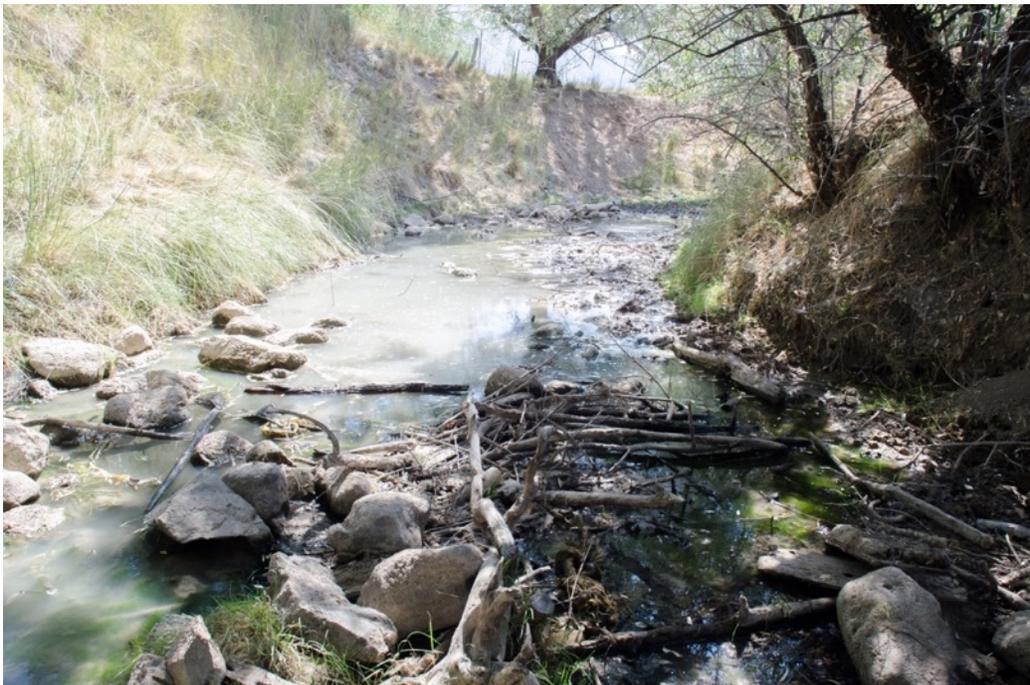
Figure 30. Currant Creek looking downstream of Burraston Ponds outlet, August 2016. Low flows, increased exposed substrates, algal blooms, stagnant conditions, and Corbicula dominate the creek.

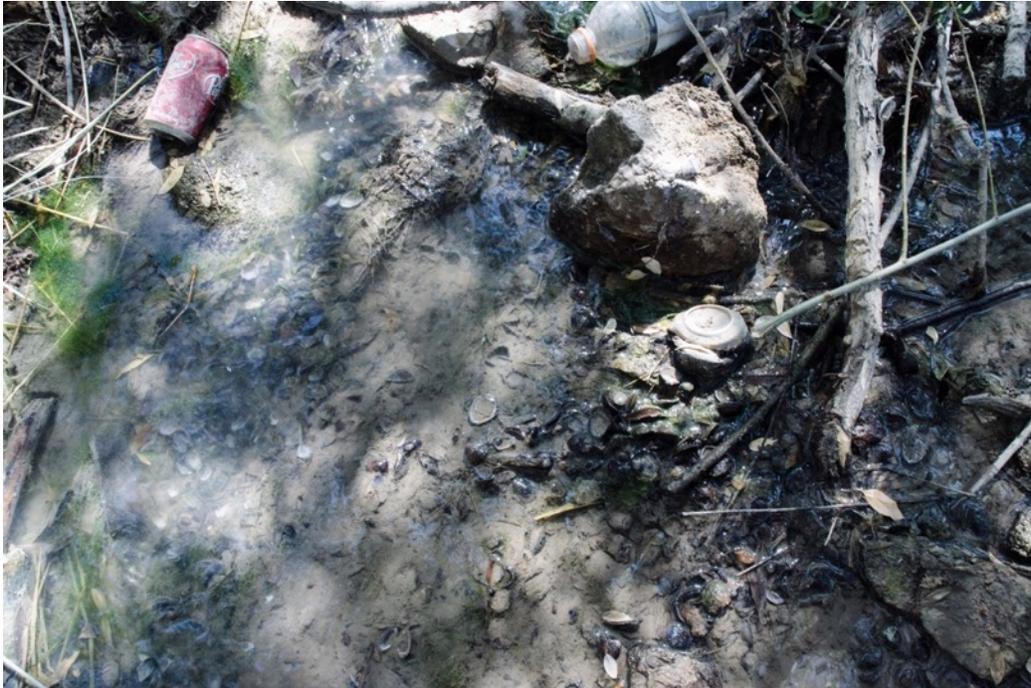
Figure 31. Trashed out, stagnant section of Currant Creek at outlet of Burraston Ponds, August 2016. Note all of the exposed Corbicula shells becoming exposed due to low flows.

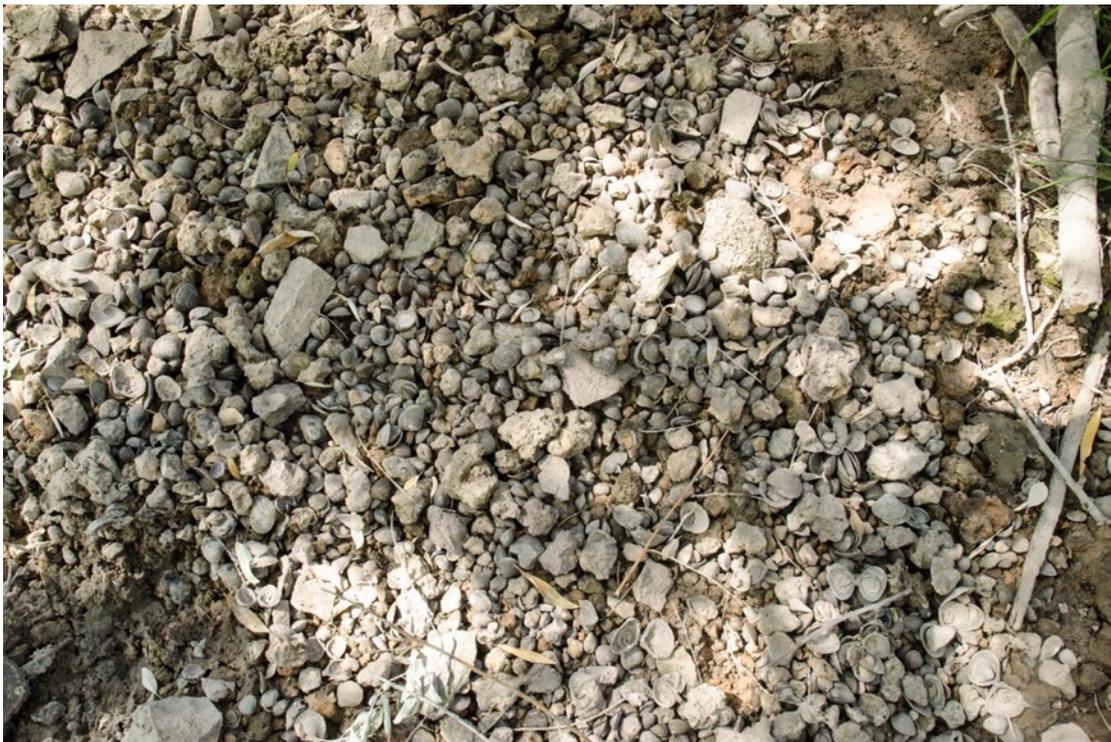
Figure 32. Corbicula left high and dry. This was normally wetted substrate in Currant Creek at Burraston Ponds. Photo taken August 2016.

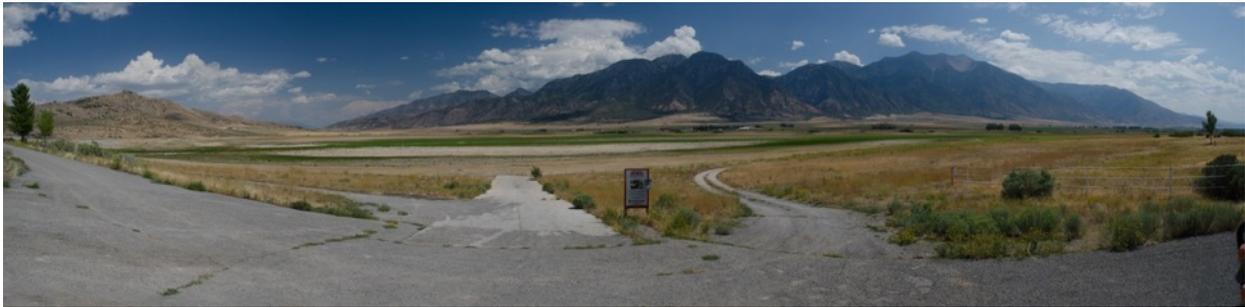
Figure 33. Mona Reservoir high and dry. August 2016.

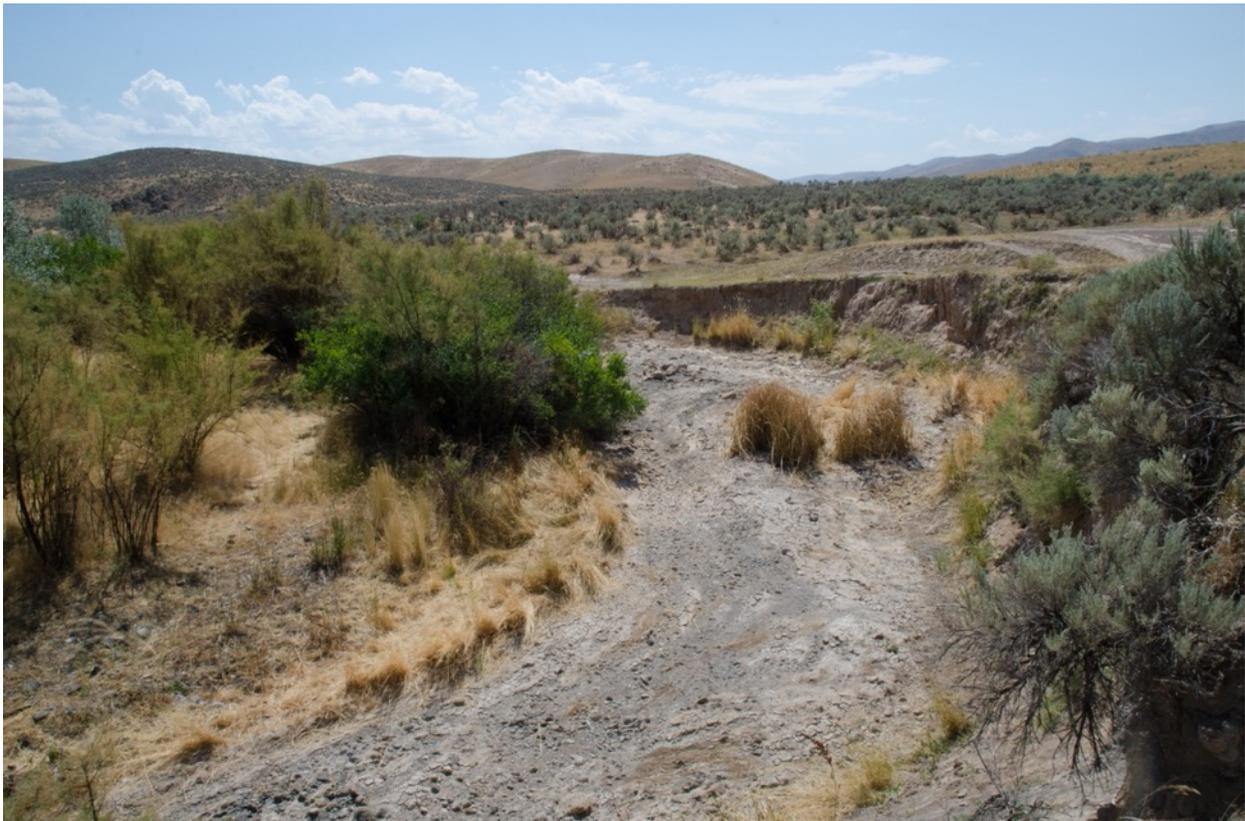
Figure 34. Currant Creek dry from Mona Reservoir (also dry) downstream to about 100 meters of this photo where springs recharge occurs.

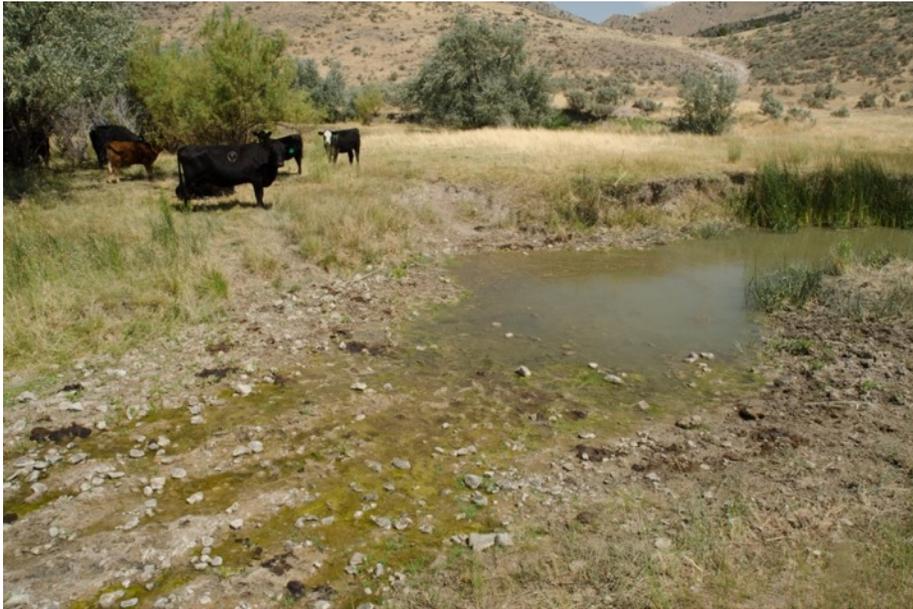
Figure 35. Several cattle patrol one of the last remaining occupied Anodonta habitats in the Jordan River drainage at Currant Creek, near Goshen Canyon, August 2016. Currant Creek is recharged from springs about 10 meters upstream (right side of photo) but is immediately impaired from poorly managed cattle grazing practices.

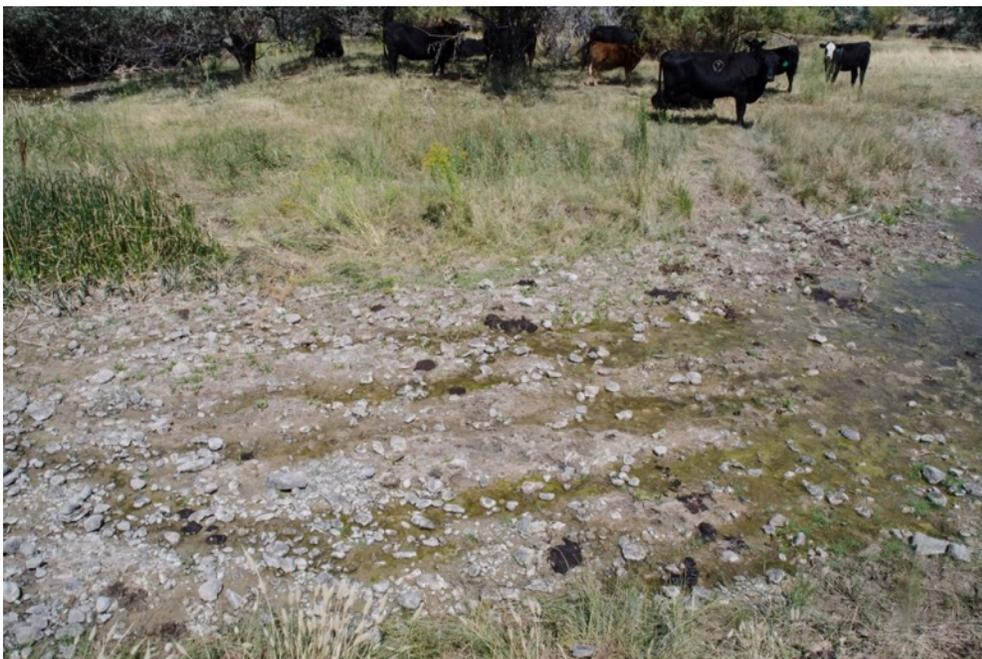
Figure 36. Limited spring recharge in Currant Creek at beginning of Goshen Canyon becomes impaired by cattle.

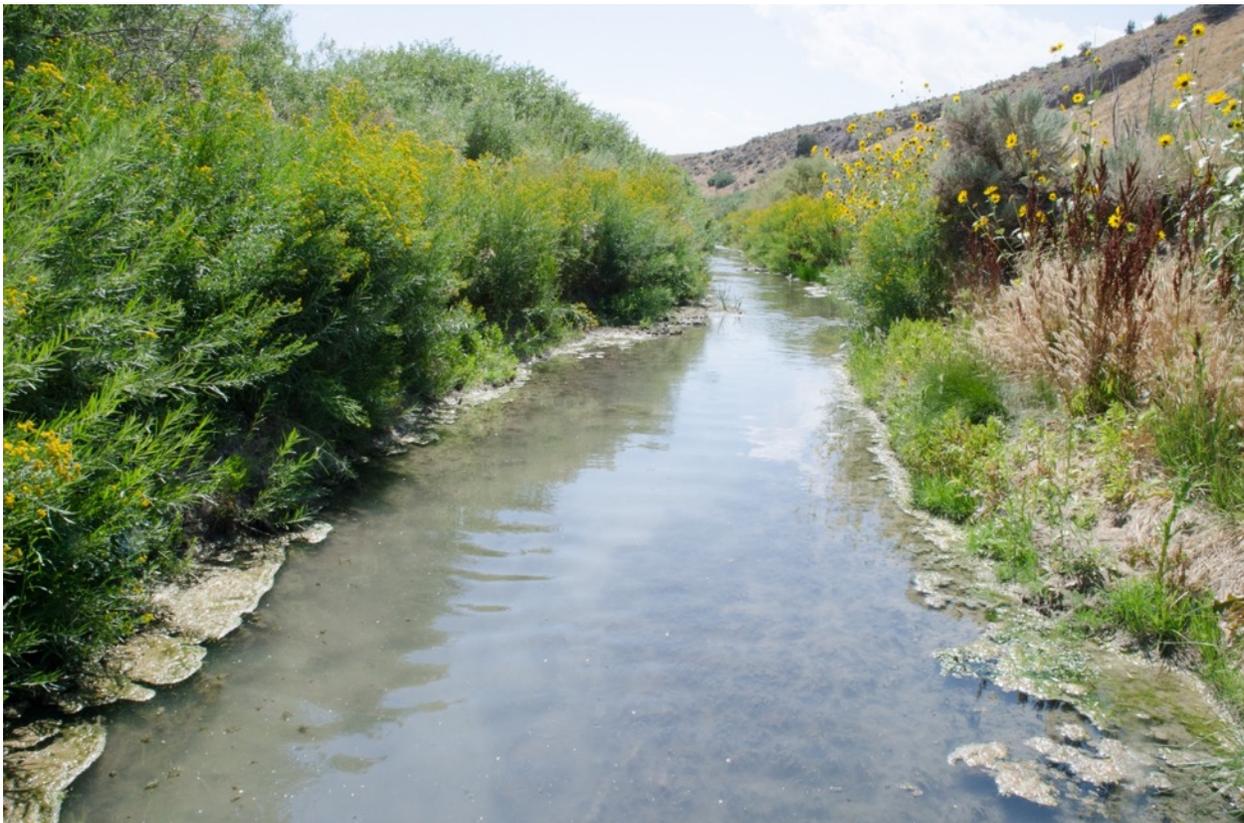
Flows increased going downstream in Goshen Canyon from additional spring recharge and five live adult *Anodonta* were found just upstream of an irrigation check dam (Figure 37 and 38) (latitude: 39°53'47.03"N, longitude: 111°53'17.77"W).

Figure 38. Section of Currant Creek in Goshen Canyon where several Anodonta still survived, August 2016.

There is an urgent need to conduct more intensive research on Currant Creek in Goshen Canyon and to determine the viability of this remaining Anodonta population, which may number << 10 individuals.

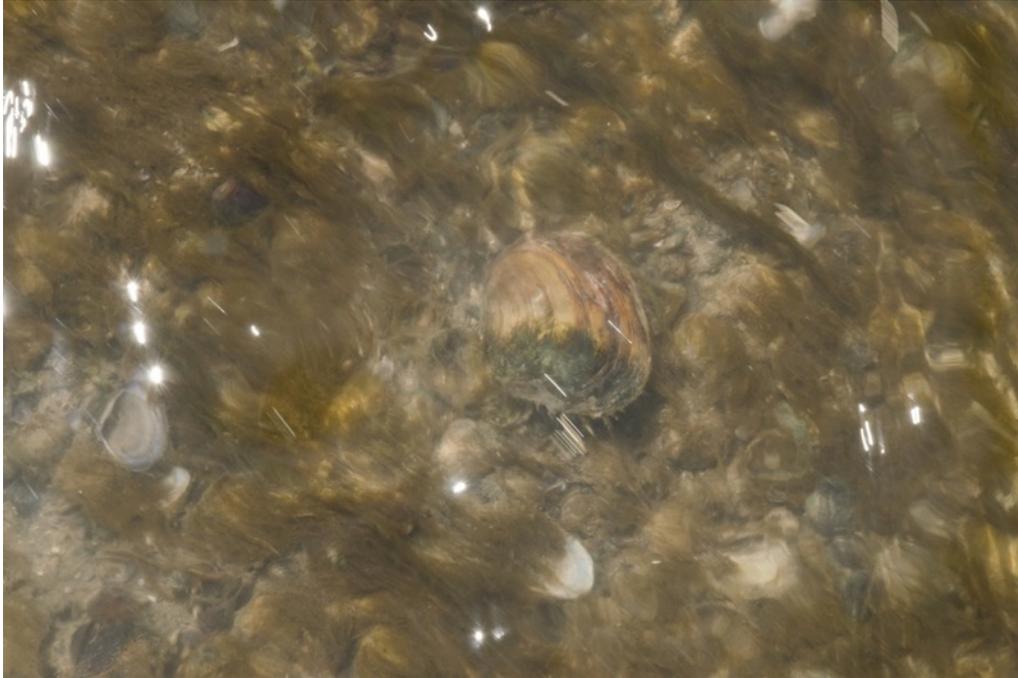
Figure 39. "No Vacancy: Anodonta on the run", Currant Creek, Goshen Canyon. Exposed Anodonta apparently trying to escape surroundings including water quality problems or just too many Corbicula.

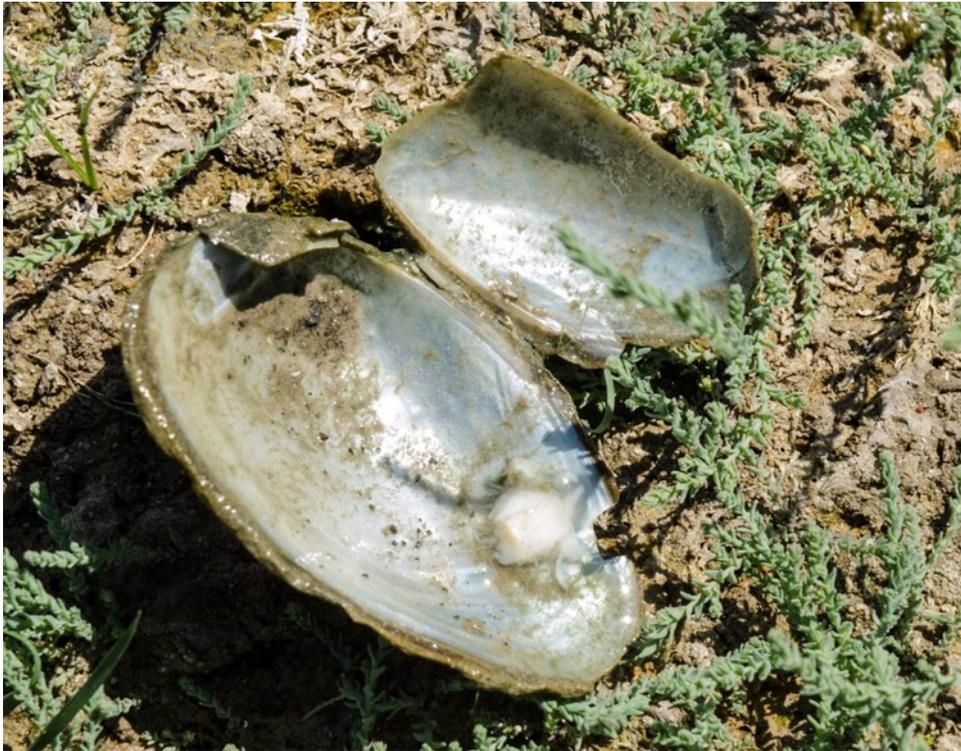
Figure 41. "Just not fast enough". *Anodonta* recently killed and fed on by raccoon. Notice some soft tissue remains.

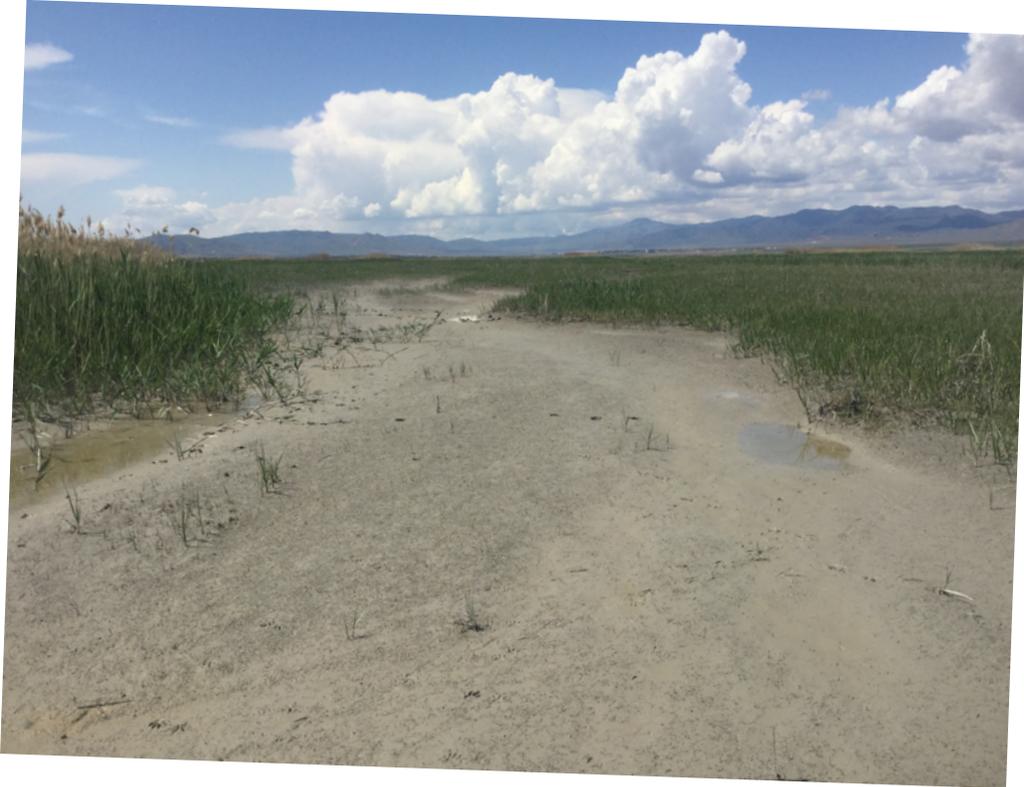
Figure 42. Currant Creek streambed on May 26, 2016. This 1 km surveyed section of Currant Creek was dry. Only a few puddles from Utah Lake waters or rain events were present.

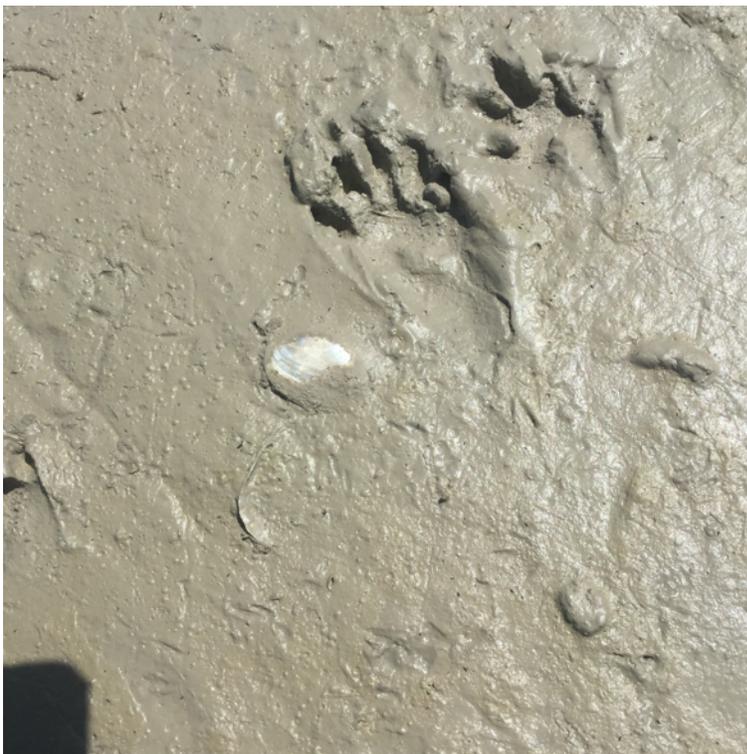
Figure 43. Anodonta weathered shell fragment in Currant Creek mud at mouth Utah Lake.

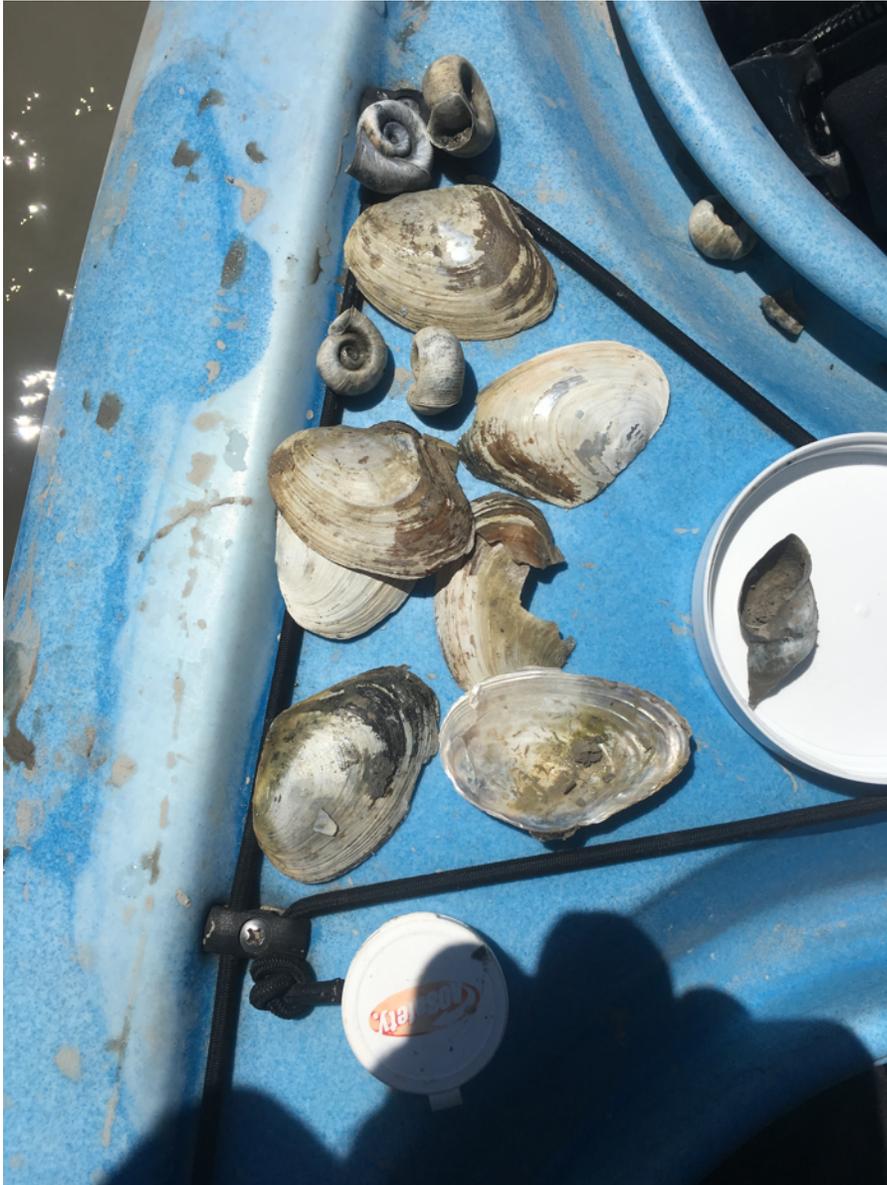
Figure 44. Several weathered *Anodonta* shells and large gastropod shells found in dry Carrant Creek sediments near confluence with Utah Lake. Notice the large *Lymnaeidae* shell in white jar top and the large *Planorbidae* shells.

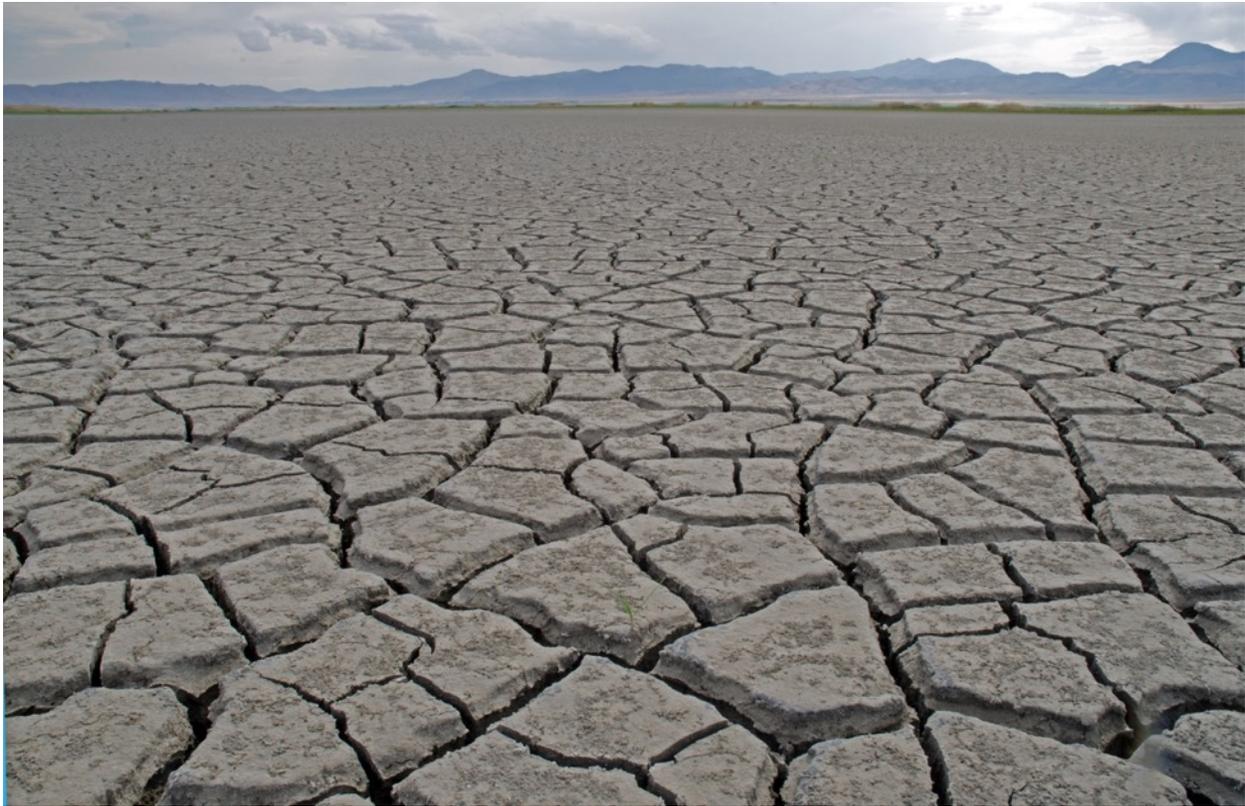
Figure 45. Goshen Bay dry in late August 2016. View is looking south towards dry Currant Creek.

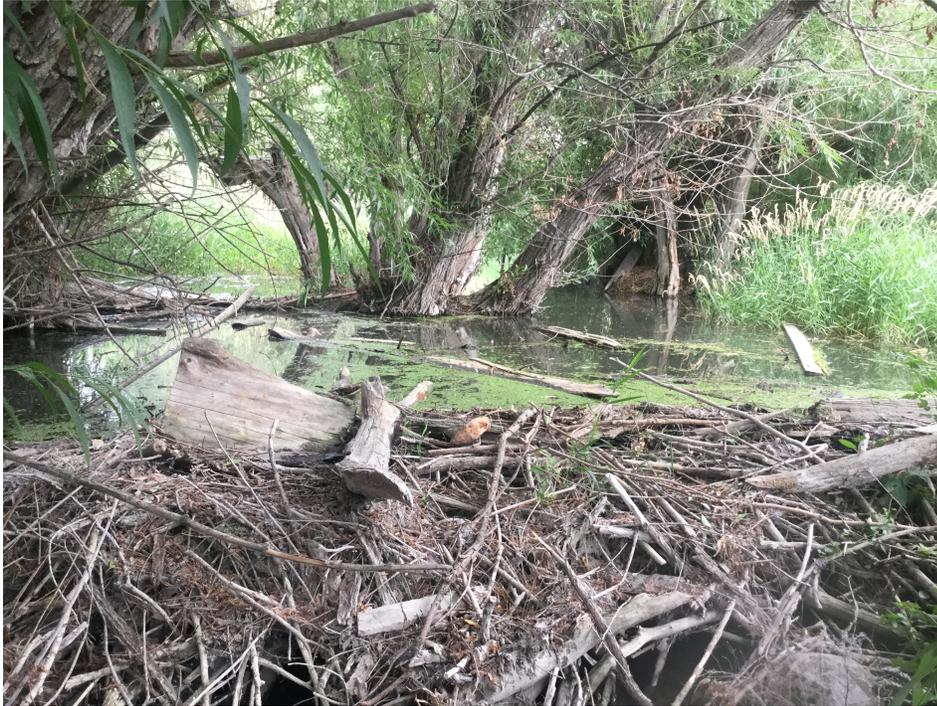
Figure 46. Spring creek beaver dam and trash.

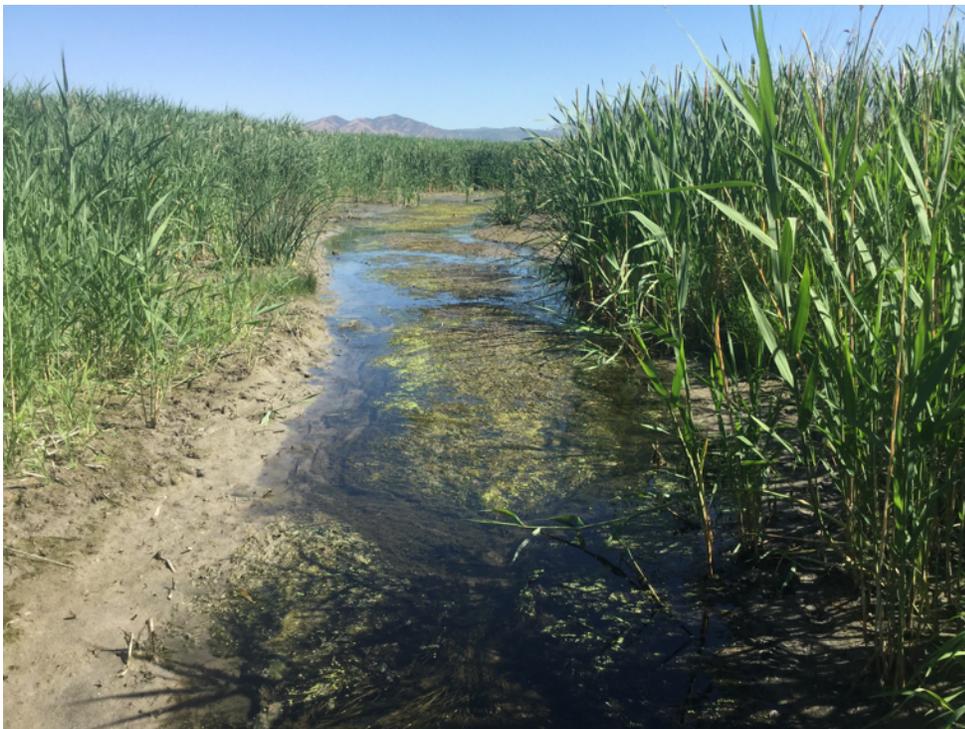
Figure 47. Disjunct flow of Spring Creek at confluence with Utah Lake.

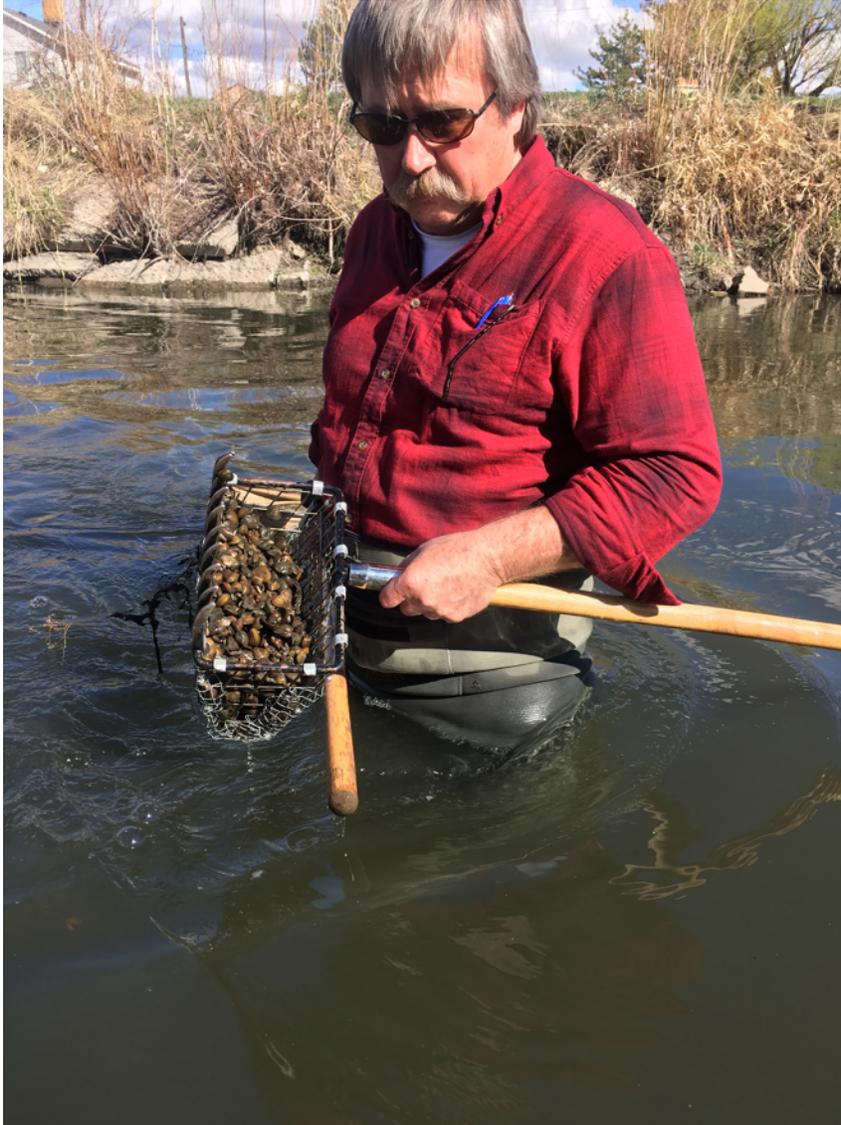
Thousands of live and dead *Corbicula* were found in this section of the Jordan River. In one location, each rake of the clam rake produced hundreds of clams (Figure 48). No live, recently dead, or weathered *Anodonta* shell fragments were found. The Jordan River obviously was very good habitat for native mussels and their apparent disappearance is a tragic loss for this impaired ecosystem.

Figure 48. Dr. Theron Miller with a clam rake brimming with Corbicula. Densities were the highest yet found in the Jordan River and equaled or surpassed densities in other productive locations in the drainage.

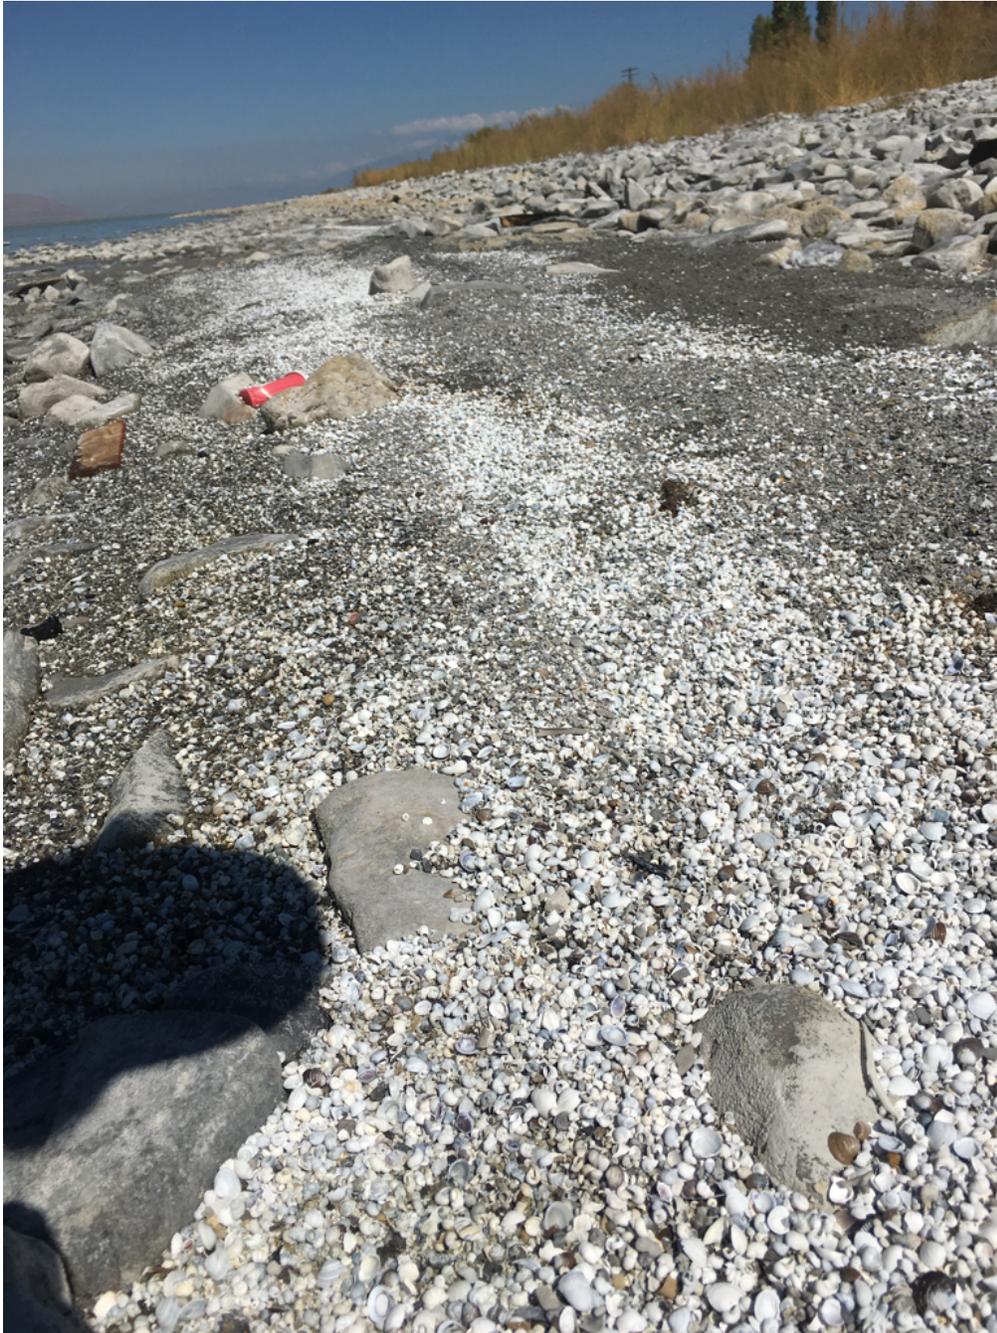
but this is no longer the case (Figures 49 and 50). Reasons for the decline of native mollusks, particularly *Anodonta* and *Margaritifera* in the drainage are discussed in detail in the Richards 2015 reports.

Figure 49. Wave washed piles of thousands of mollusk shells, mostly heterobranch and prosobranch snails but including fingernail clams, Corbicula, and an occasional Anodonta fragment, along the east shore of Goshen Bay, Utah Lake, September 2016. Utah Lake was once home to this amazing assemblage of mollusks and its loss is tragic.

Continued surveying in additional locations and monitoring of the last remaining known populations are needed. Also, population dynamic studies for each of the remaining native mollusk taxa and in particular the native bivalves and non-pulmonate snails are urgently required. Population dynamic studies of the last populations of native mollusks in the drainage are indispensable to determine the causes of their disappearance, predict their extinction risk, and suggest management strategies that may circumvent or postpone their extinction.

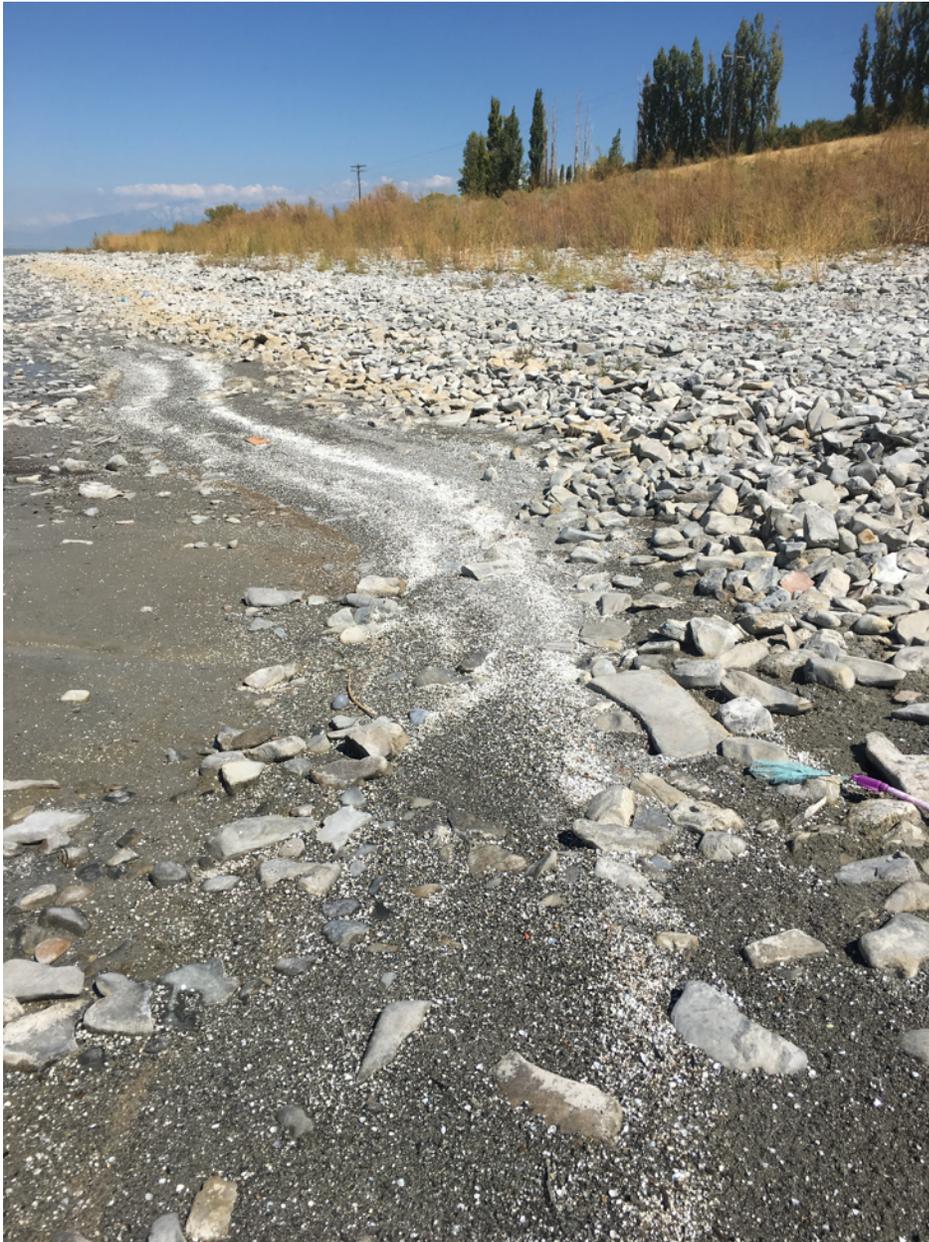
Figure 50. Piles of wave washed mollusk on eastern shore of Goshen Bay, Utah Lake, September, 2016. Shell piles are white curved lines and shell layer is several cm thick.
